# The Palestinian Presidential Committee for the Restoration of the Church of the Nativity

*Contract Number: NCRW-PI-13/1*

## Brief Construction Progress Report

September 15, 2013 – May 23, 2019

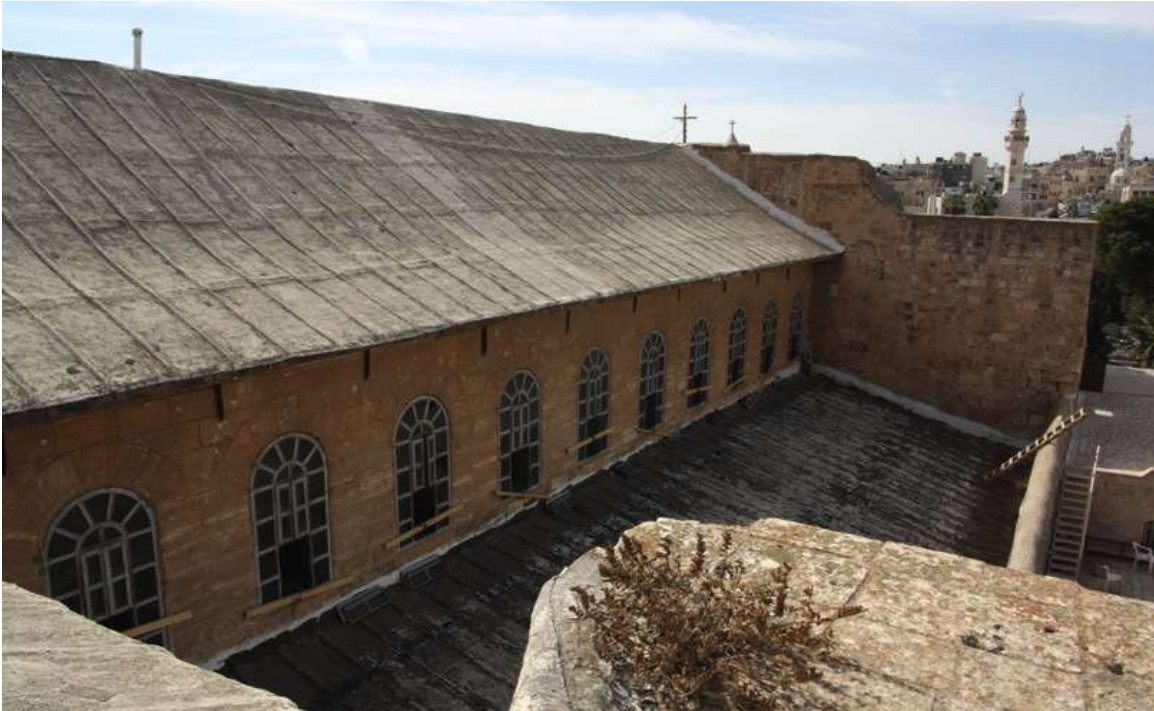
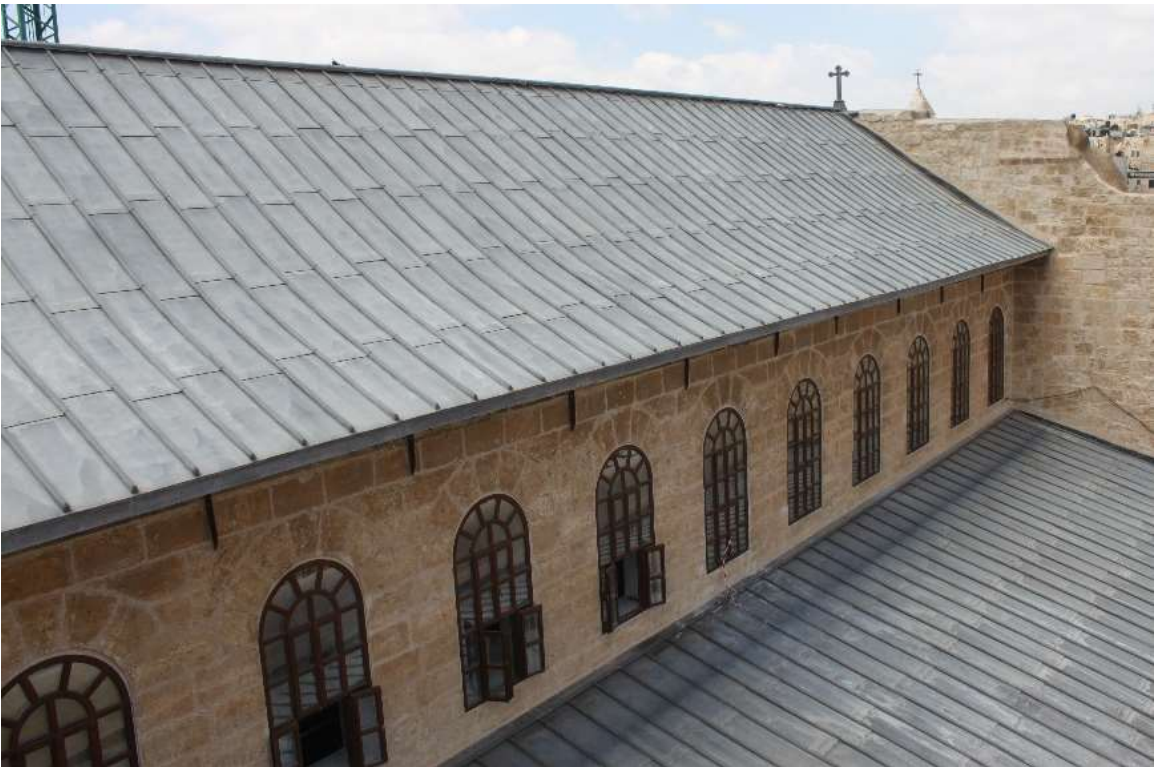
- a. The whole roof was covered with new lead sheets with a total area of 1625m<sup>2</sup>.
- b. Less than 8% of the wood trusses have been replaced with ancient wood brought from Italy.
- c. The seismic performance of the basilica had been improved by adding seismic steel connectors.

*The lead roof before and after restoration*

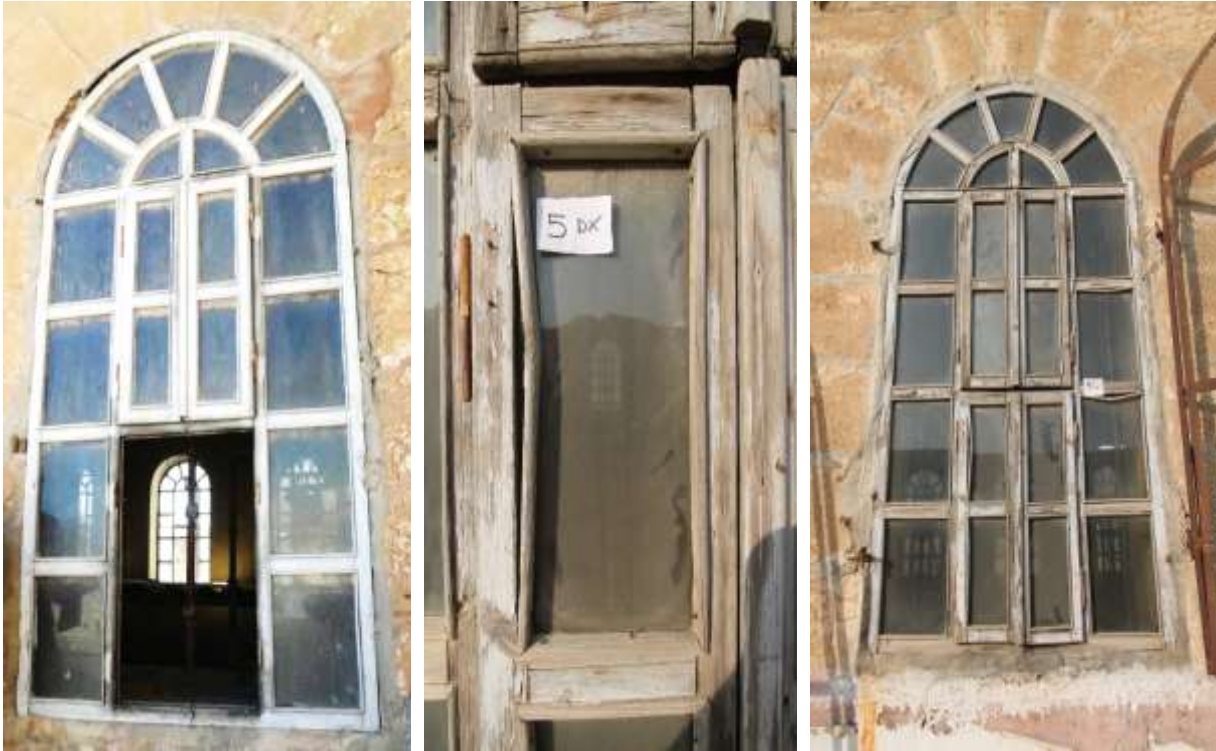
*The damaged wooden windows*

All Church's 42 deteriorated wooden windows were replaced with new wooden windows with UV double glass.

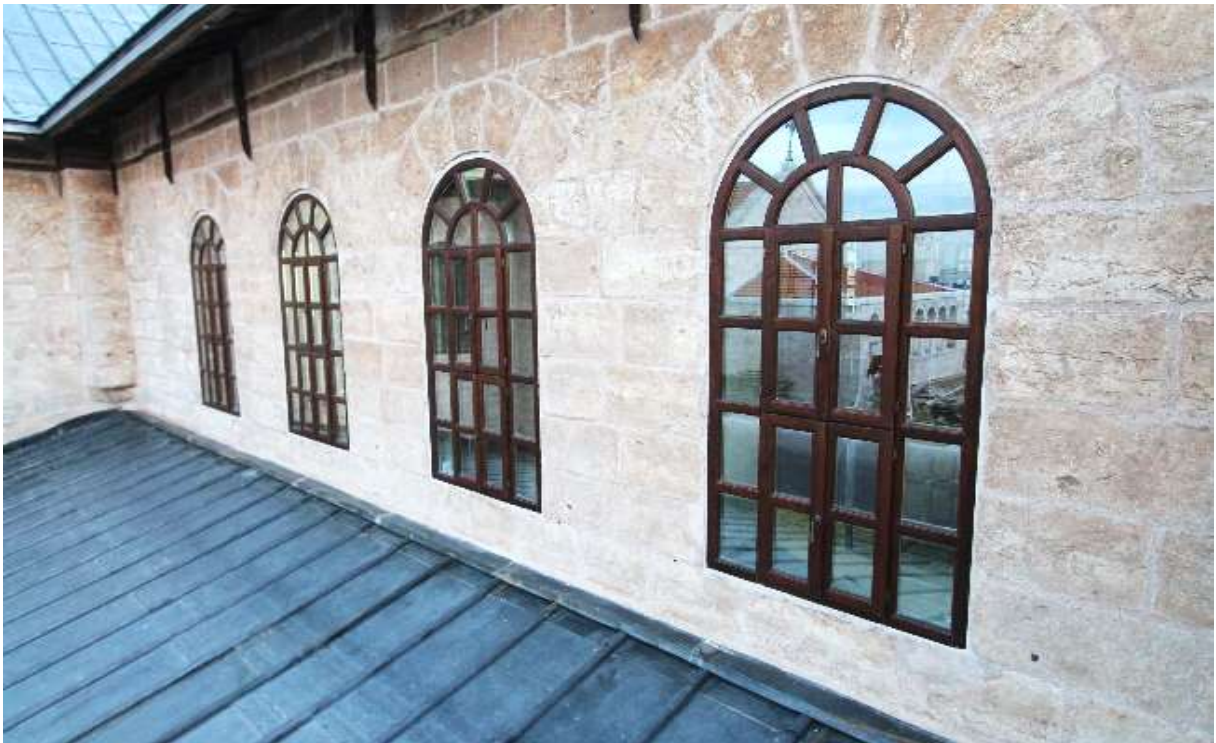
*The new wooden windows*

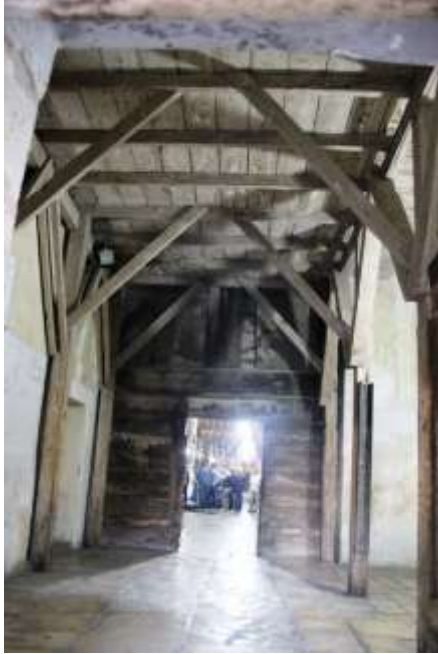
- a. The three damaged cross vaults of the Narthex area were restored and consolidated and a new steel structure was installed to bear the new roof floor and to connect the opposite facades (The Basilica & the Narthex facades)
- b. By the completion of the consolidation of the Narthex cross vaults, it was possible to remove the huge wooden propping placed inside the Narthex since 1930s duration the British mandate.

Narthex before restoration

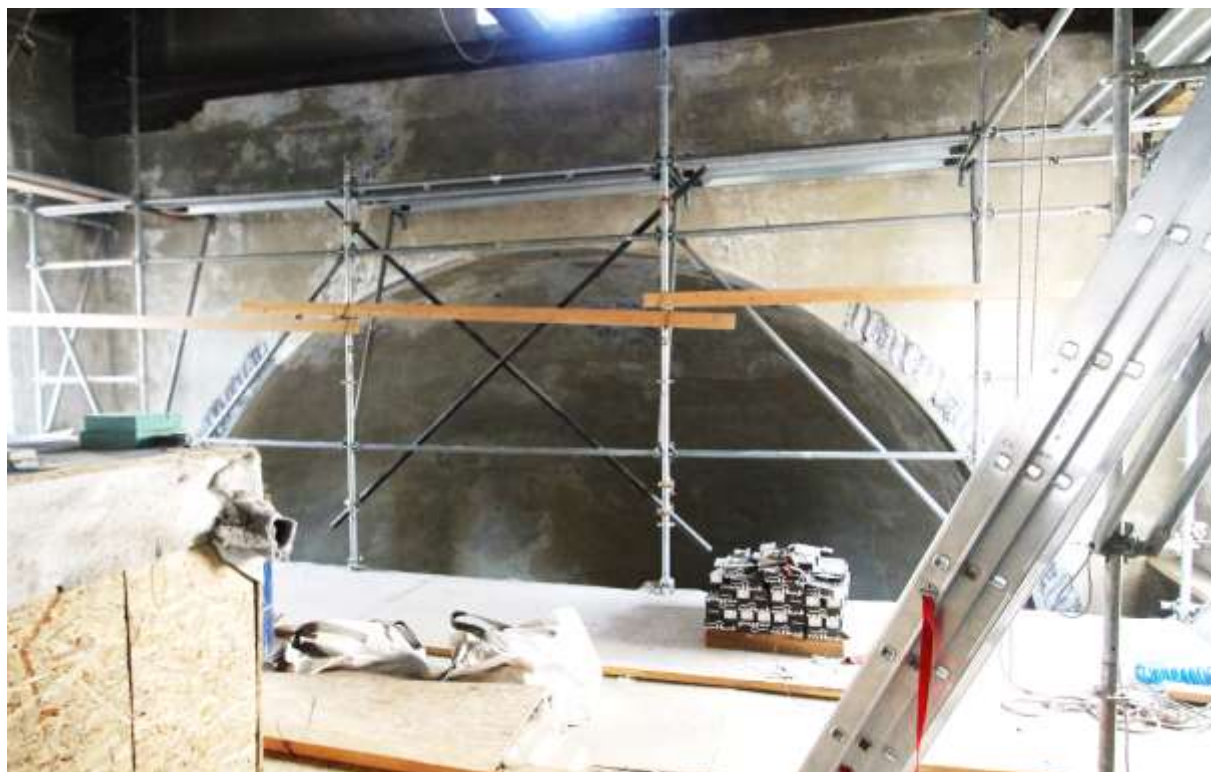
3365m<sup>2</sup> of the internal plastering have been consolidated including the replacement of the cement patches with a compatible lime plastering layers.

*The internal plastering surfaces before restoration*

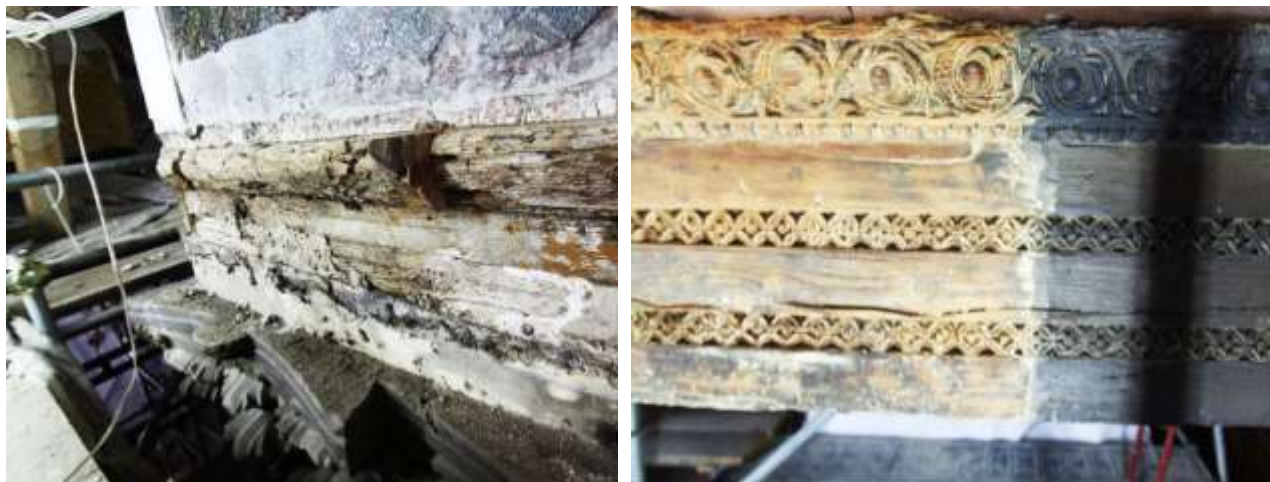
52 segments of the wooden architraves with a total length of 154m were renovated. The works include the replacement of the most deteriorated inner parts and the consolidation of all decorative outer surfaces.

*The wooden Architraves before restoration*

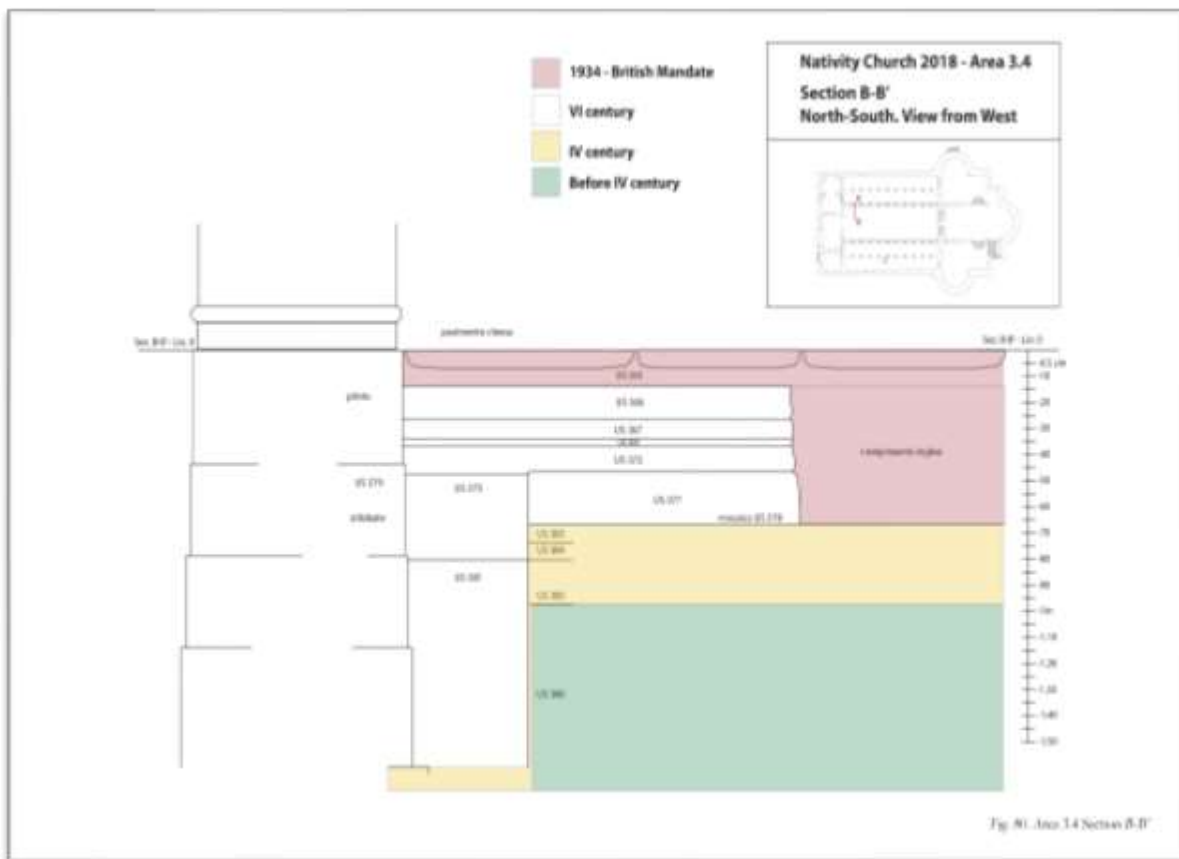
*One of the cross sections created based on the Archeological excavation and analysis*

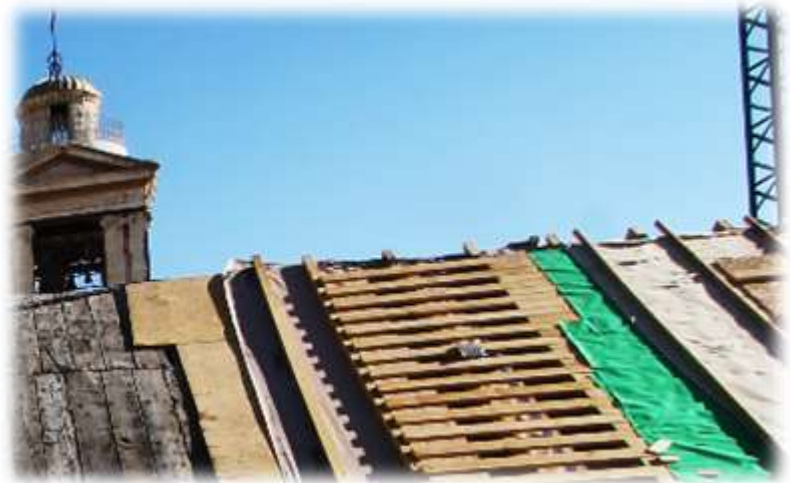
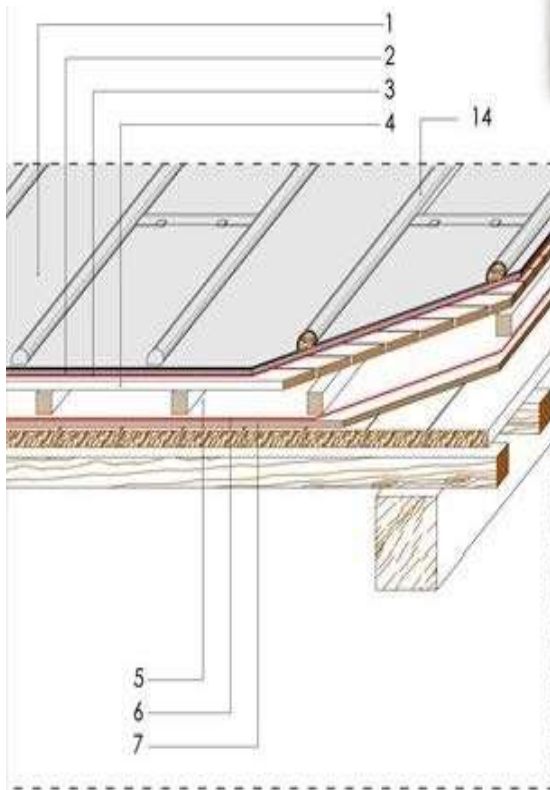
After the restoration of the boards and purlins and the replacement of the decayed parts, the roof layers were installed according to the below detail to create a ventilation system and a durable waterproofing coverage. The roof layers included the installation of phenolic plywood layer, vapor control waterproofing membrane, ventilation gaps joists, wooden planks deck, high vapor permeability waterproofing membrane, natural sheep wool layer and the lead sheets.

- 1 - LEAD ROOF - thickness mm 2
- 2 - 100% SHEEP'S WOOL BLANKET  
high density 100 kg/mc - thickness mm 10
- 3 - HIGH VAPOUR PERMEABILITY WATERPROOF MEMBRANE - SD<0,04
- 4 - WOODEN PLANK'S DECK WITH GAP FOR MICRO VENTILATION  
PLANK'S DIMENSIONS:  
20 (thickness) x 120 (width) x 3500=5500(enght) (m.u. = mm)  
DIMENSION OF THE GAP BETWEEN THE BOARD = 5 mm
- 5 - VENTILATION GAP'S JOISTS 50x60 mm
- 6 - VAPOUR CONTROL WATERPROOF MEMBRANE - SD>2
- 7 - PLYWOOD - DIMENSIONS 2440 x 1220 x 20 mm
- 8 - EXISTING WOODEN PLANK'S DECK, TO BE RESTORED
- 9 - EXISTING PURLINS, TO BE RESTORED
- 13 - COPPER CLIPS - thickness 1,0 mm
- 14 - WOOD CORED ROLL
- 21 - COPPER SCREWS 5 x 35 (Ø x L) mm
- 22 - LEAD PLATED COPPER CLIPS - thickness 0,8 mm  
TO PREVENT LIFTING AND DISTORTION OF FREE EDGES OF  
ROOFING LEAD SHEET

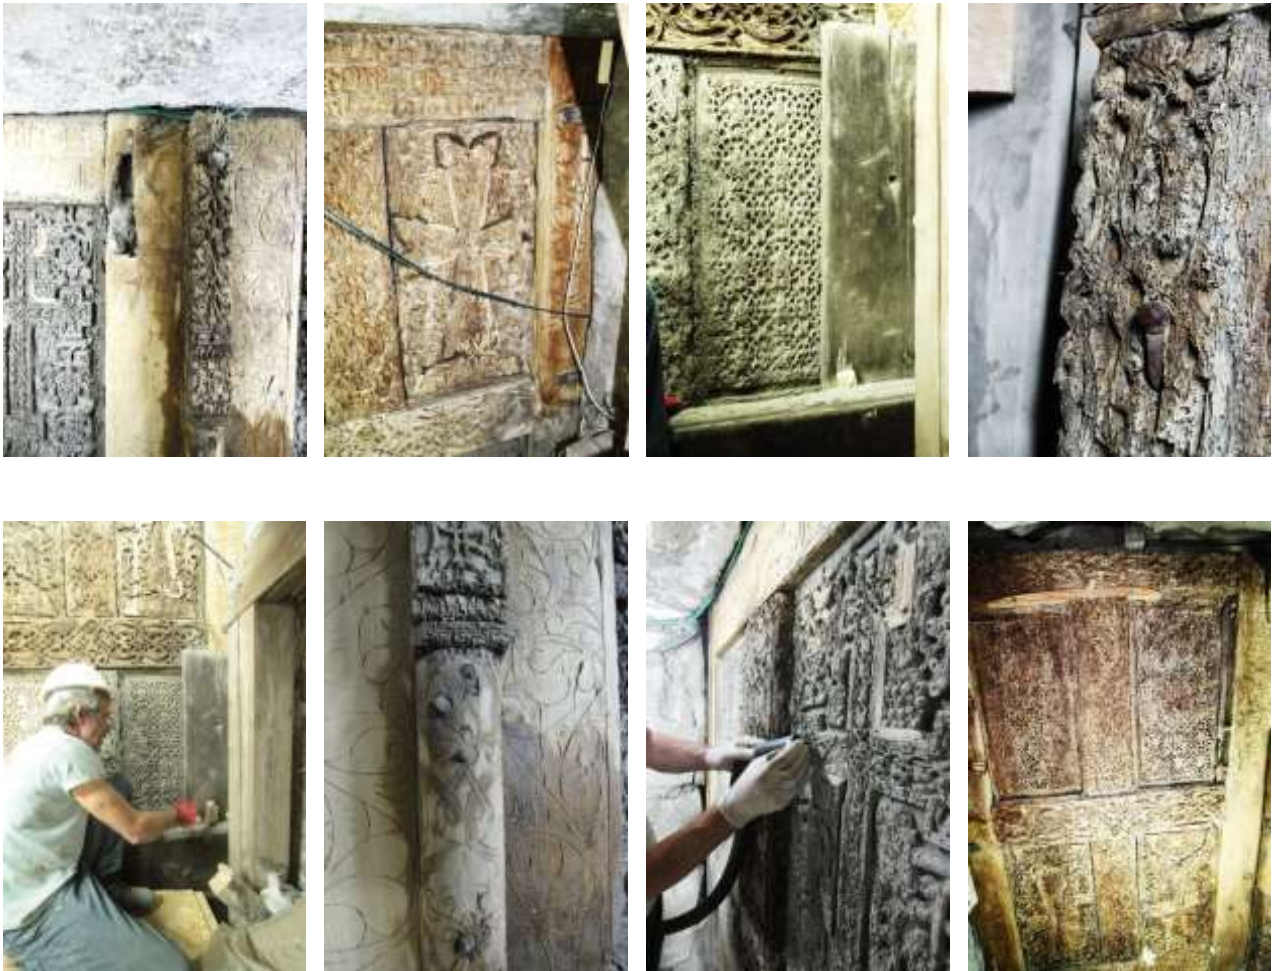
During the restoration works, it was found that the upper part of the door from the eastern side has wooden boards that hide the original wooden door, while the western part has also some part that have been uncovered to show the original carving art work. After the completion of the necessary restoration and consolidation works in December 2014, the visitors and pilgrims can see the original door and the wood carving art on the other side.

*The two sides of the narthex door before and after restoration works*

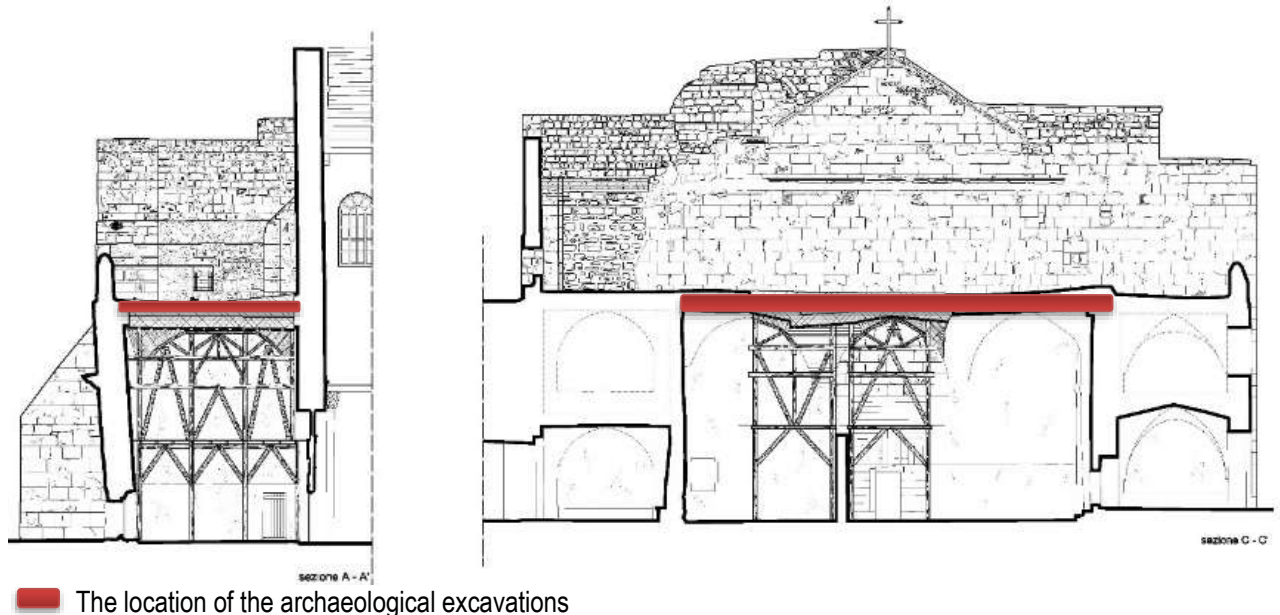
The preliminary structural reports showed that the existing cracks on the roof actually extend from the damaged vault to the adjacent vaults. This fact made it necessary to excavate the two vaults next to the damaged one to uncover the vaults stones for better understanding of the structural stability of the narthex and to make the structural simulations, modeling and analysis more realistic in order to identify the most suitable solution.

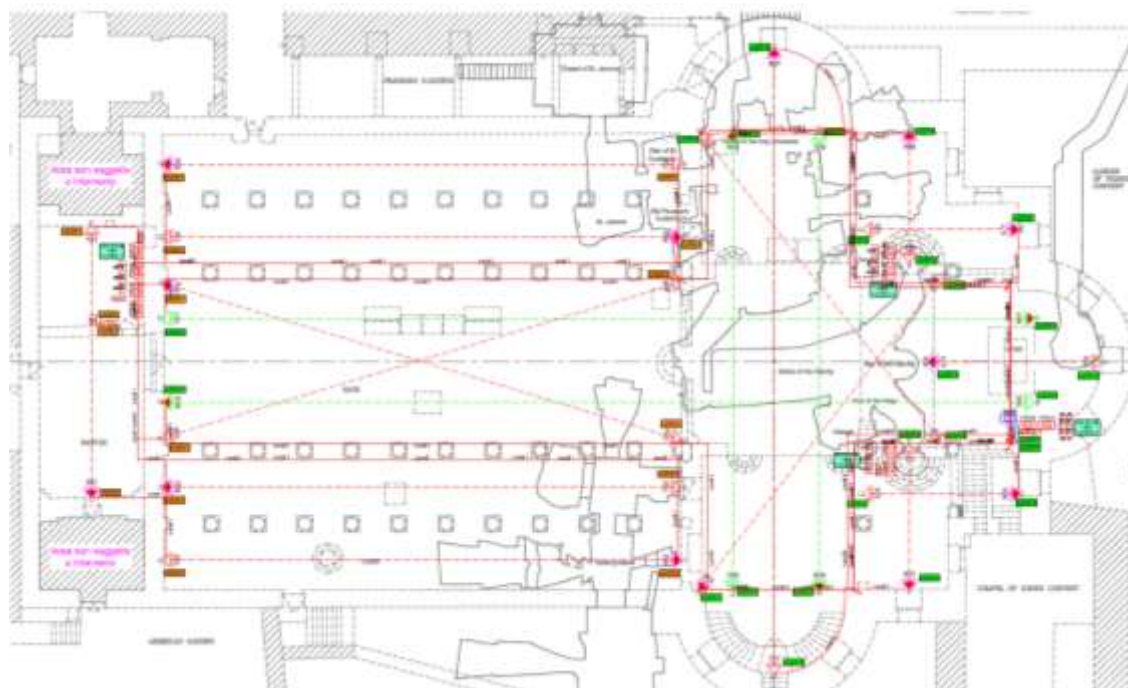
The systems installed to the roof in two levels, the lower roof at the north and south lateral naves and at the upper roof of the Central nave, transepts and apse. The device generates two infrared with different angles. These beams reflect themselves on the reflector and come back to the receiver. If a fire with flame and smoke cut the beams with known characteristics related to the dynamic of a fire in terms of intensity and timings, an alarm will be generated. This is possible even if the fire has a starting point within a distance of 7.5m on the left or on the right of the detector.
