# The Palestinian Presidential Committee for the Restoration of the Church of the Nativity

*Contract Number: NCRW-PI-13/1*

## Brief Construction Progress Report

September 15, 2013 – May 23, 2019

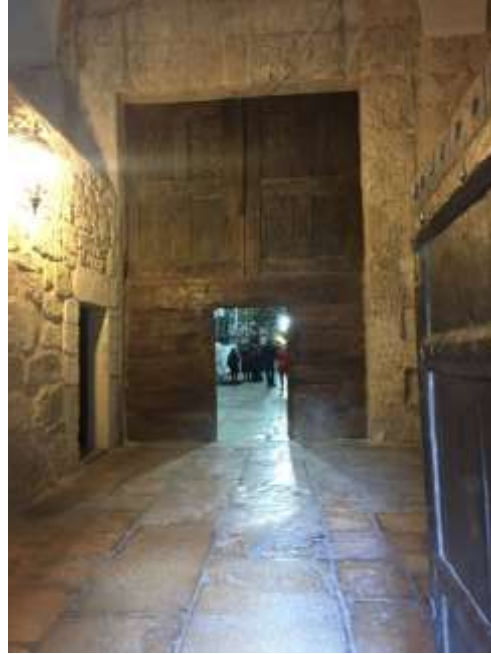
Narthex after restoration

- a. The three damaged cross vaults of the Narthex area were restored and consolidated and a new steel structure was installed to bear the new roof floor and to connect the opposite facades (The Basilica & the Narthex facades)
- b. By the completion of the consolidation of the Narthex cross vaults, it was possible to remove the huge wooden propping placed inside the Narthex since 1930s duration the British mandate.

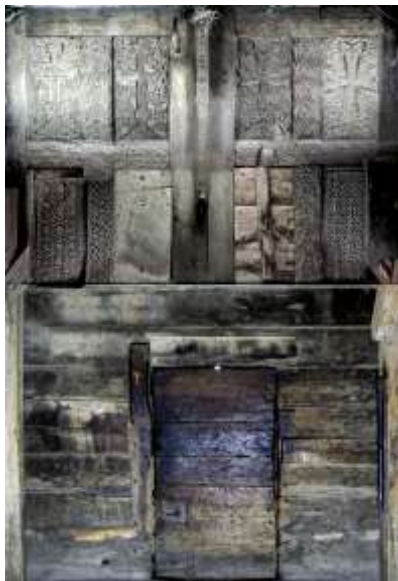
Narthex wooden door before restoration

During the restoration works, it was found that the upper part of the door from the eastern side has wooden boards that hide the original wooden door, while the western part has also some part that have been uncovered to show the original carving art work. After the completion of the necessary restoration and consolidation works in December 2014, the visitors and pilgrims can see the original door and the wood carving art on the other side.

- a. The carved Narthex eastern wooden door has been renovated and consolidated.
- b. The metal doors of the basilica have been restored including the main church access door “The door of Humility”, and the three doors leading to the three convents.

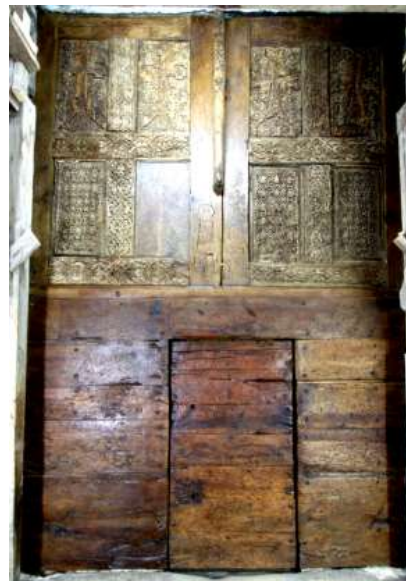
Narthex wooden door after restoration

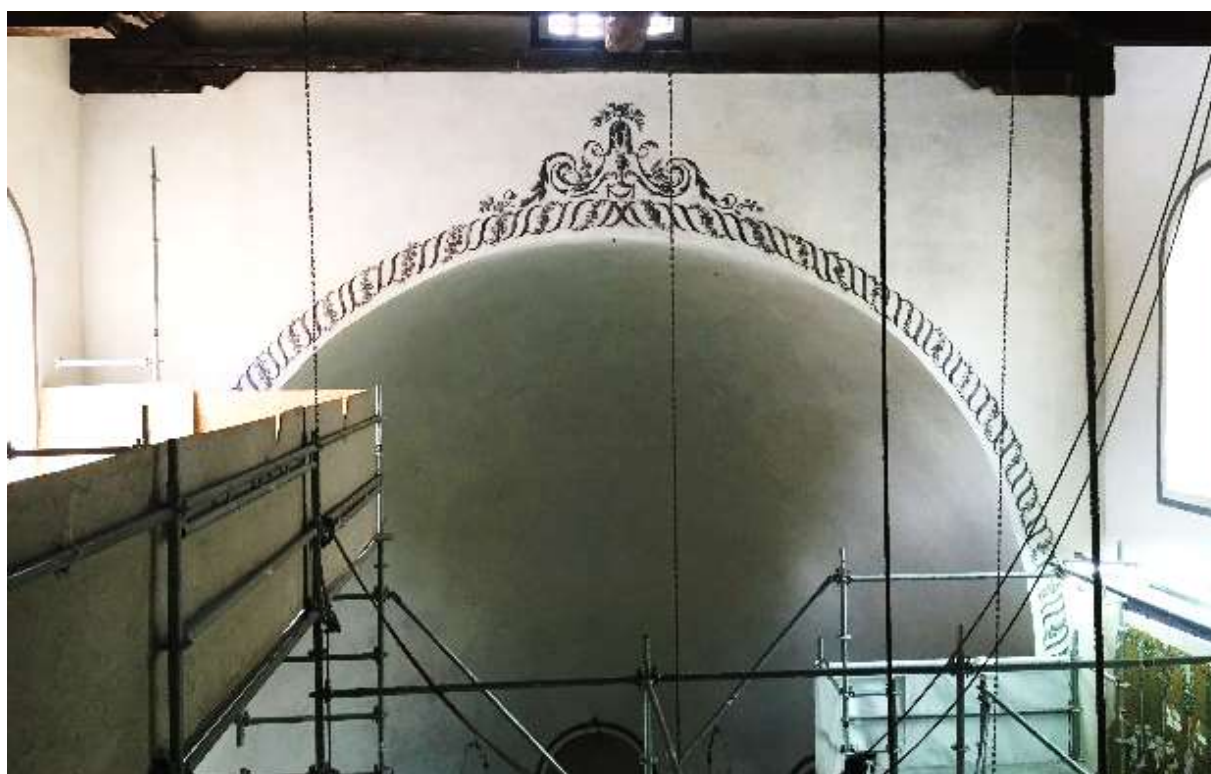
*The internal plastering surfaces after restoration*

3365m<sup>2</sup> of the internal plastering have been consolidated including the replacement of the cement patches with a compatible lime plastering layers.

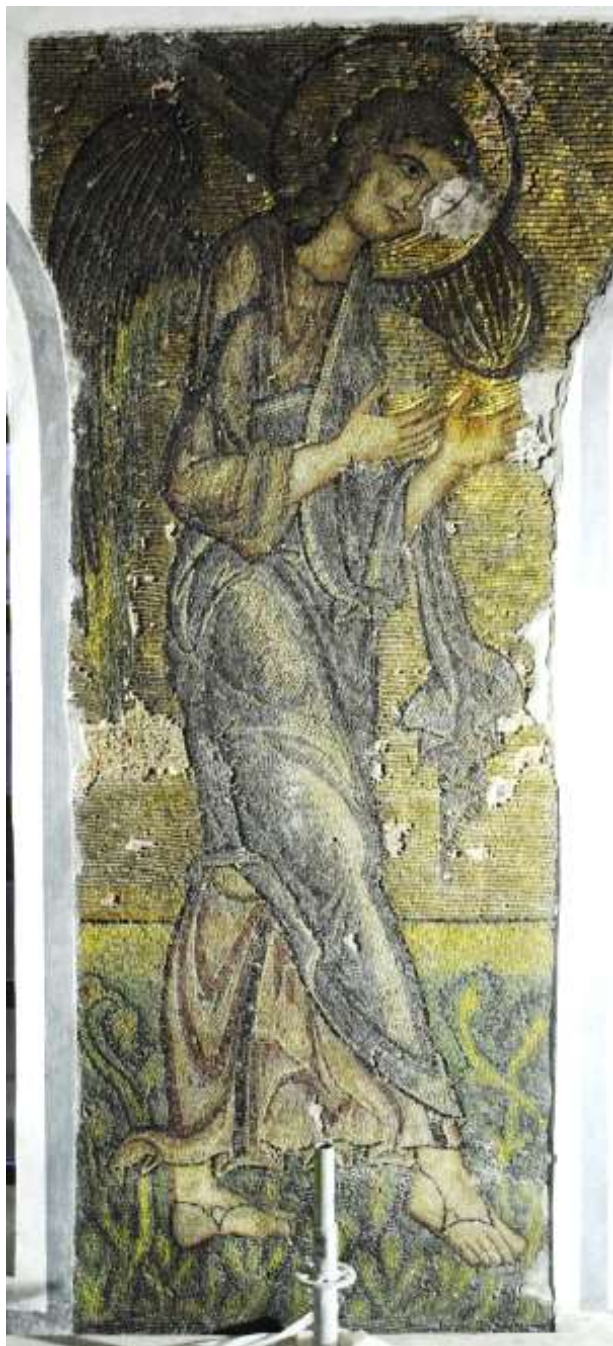
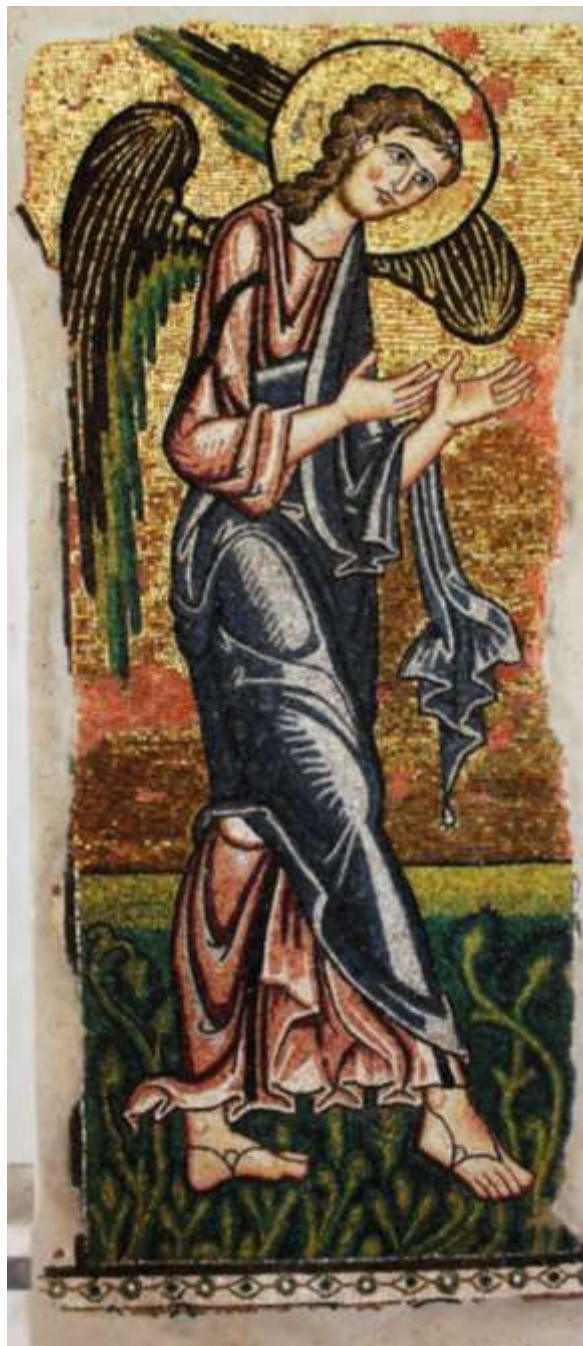
One of the wall mosaic angels before and after restoration

The whole wall mosaic with a total area of 125m<sup>2</sup> was renovated including consolidation and cleaning works. (92m<sup>2</sup> at the central nave & 33m<sup>2</sup> at the transepts and apse).

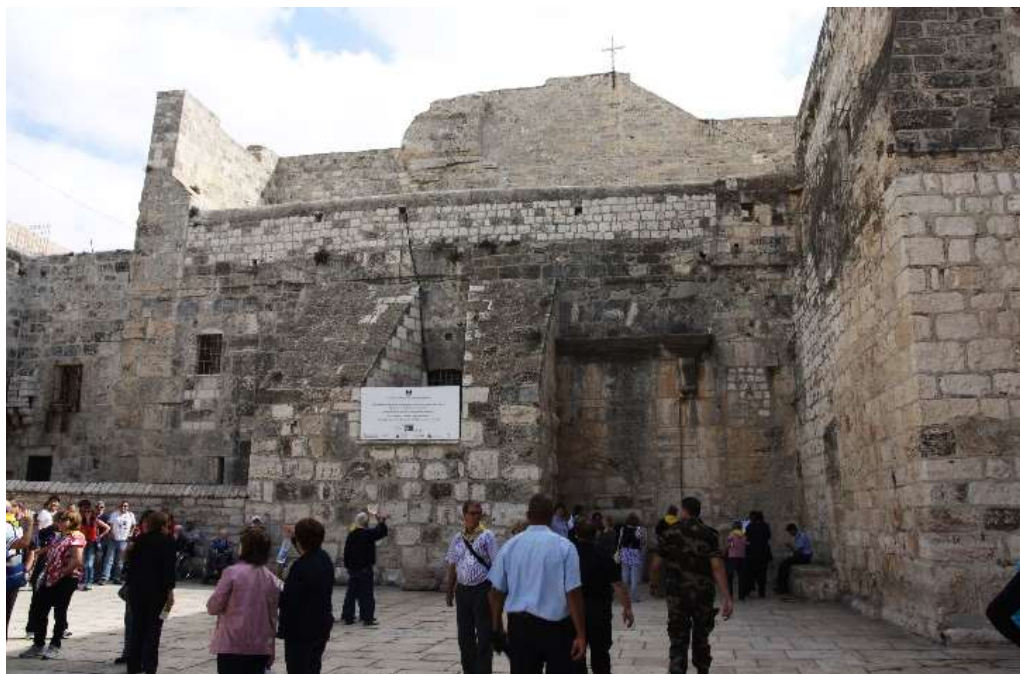
*The Basilica western facade before restoration*

- i. 928 m<sup>2</sup> already renovated (about 30%) Urgent areas.
- ii. 595 m<sup>2</sup> already renovated related to the front façade “western elevation”
- iii. 440 m<sup>2</sup> already renovated at the Northern facade
- iv. 521 m<sup>2</sup> already renovated at the Eastern façade.
- v. 592 m<sup>2</sup> already renovated at the Western façade.

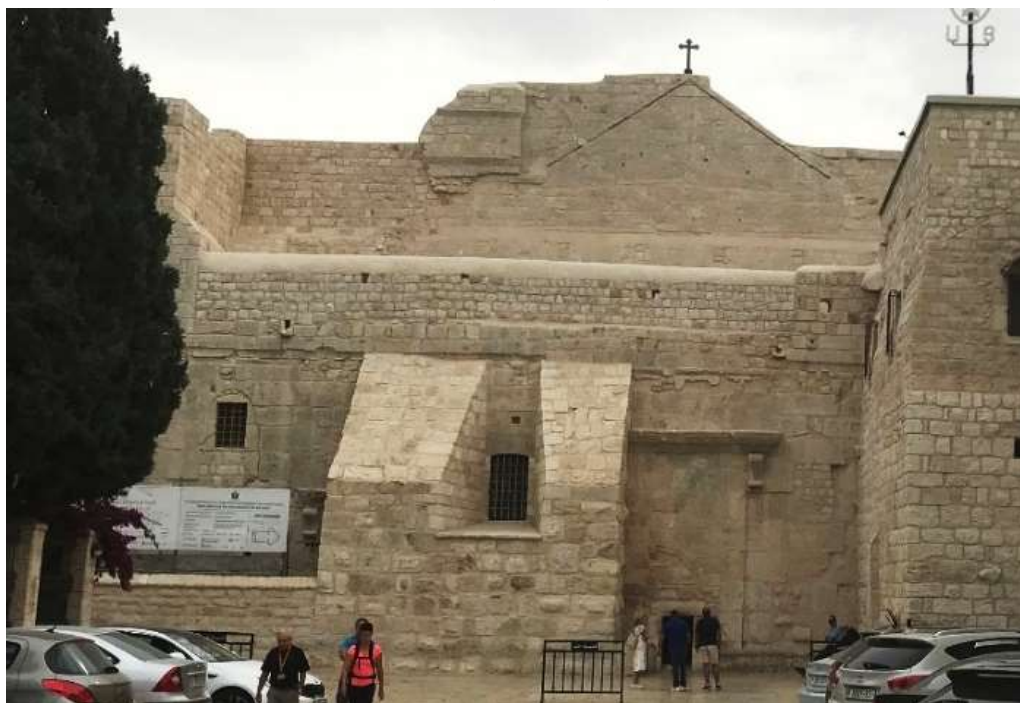
*The Basilica western facade before restoration*

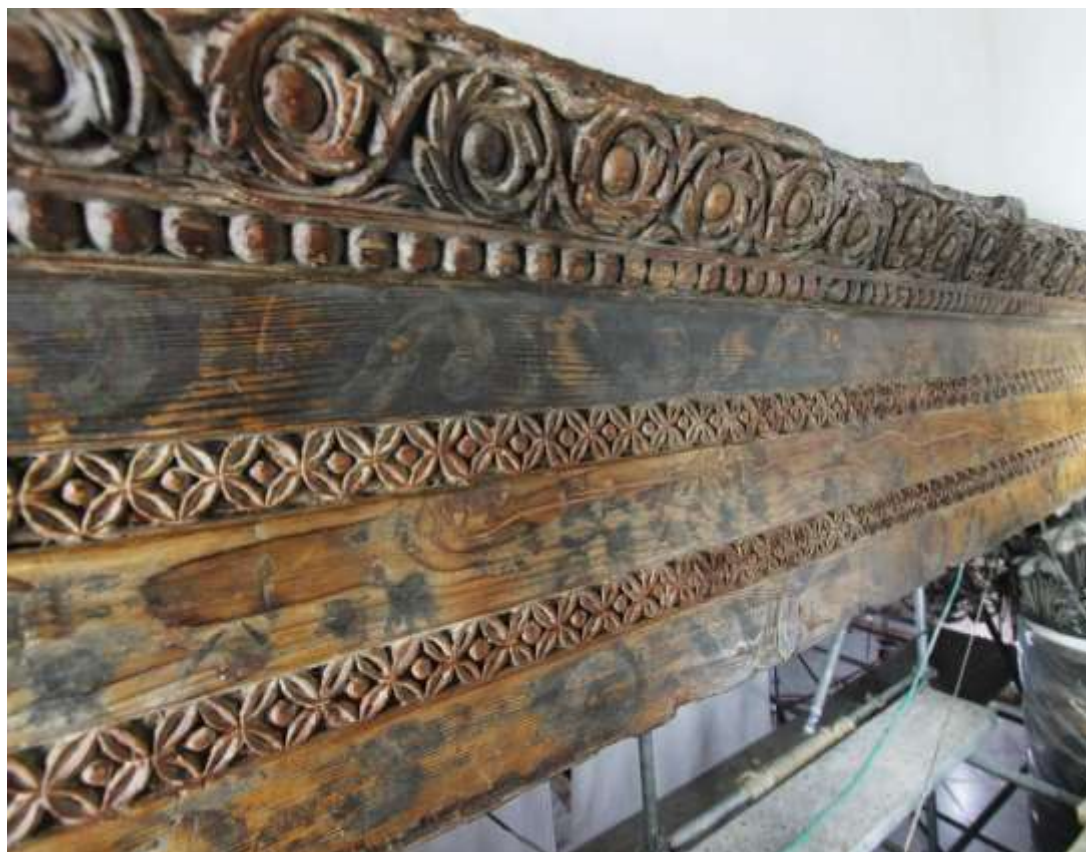
*The wooden Architraves after restoration*

52 segments of the wooden architraves with a total length of 154m were renovated. The works include the replacement of the most deteriorated inner parts and the consolidation of all decorative outer surfaces.

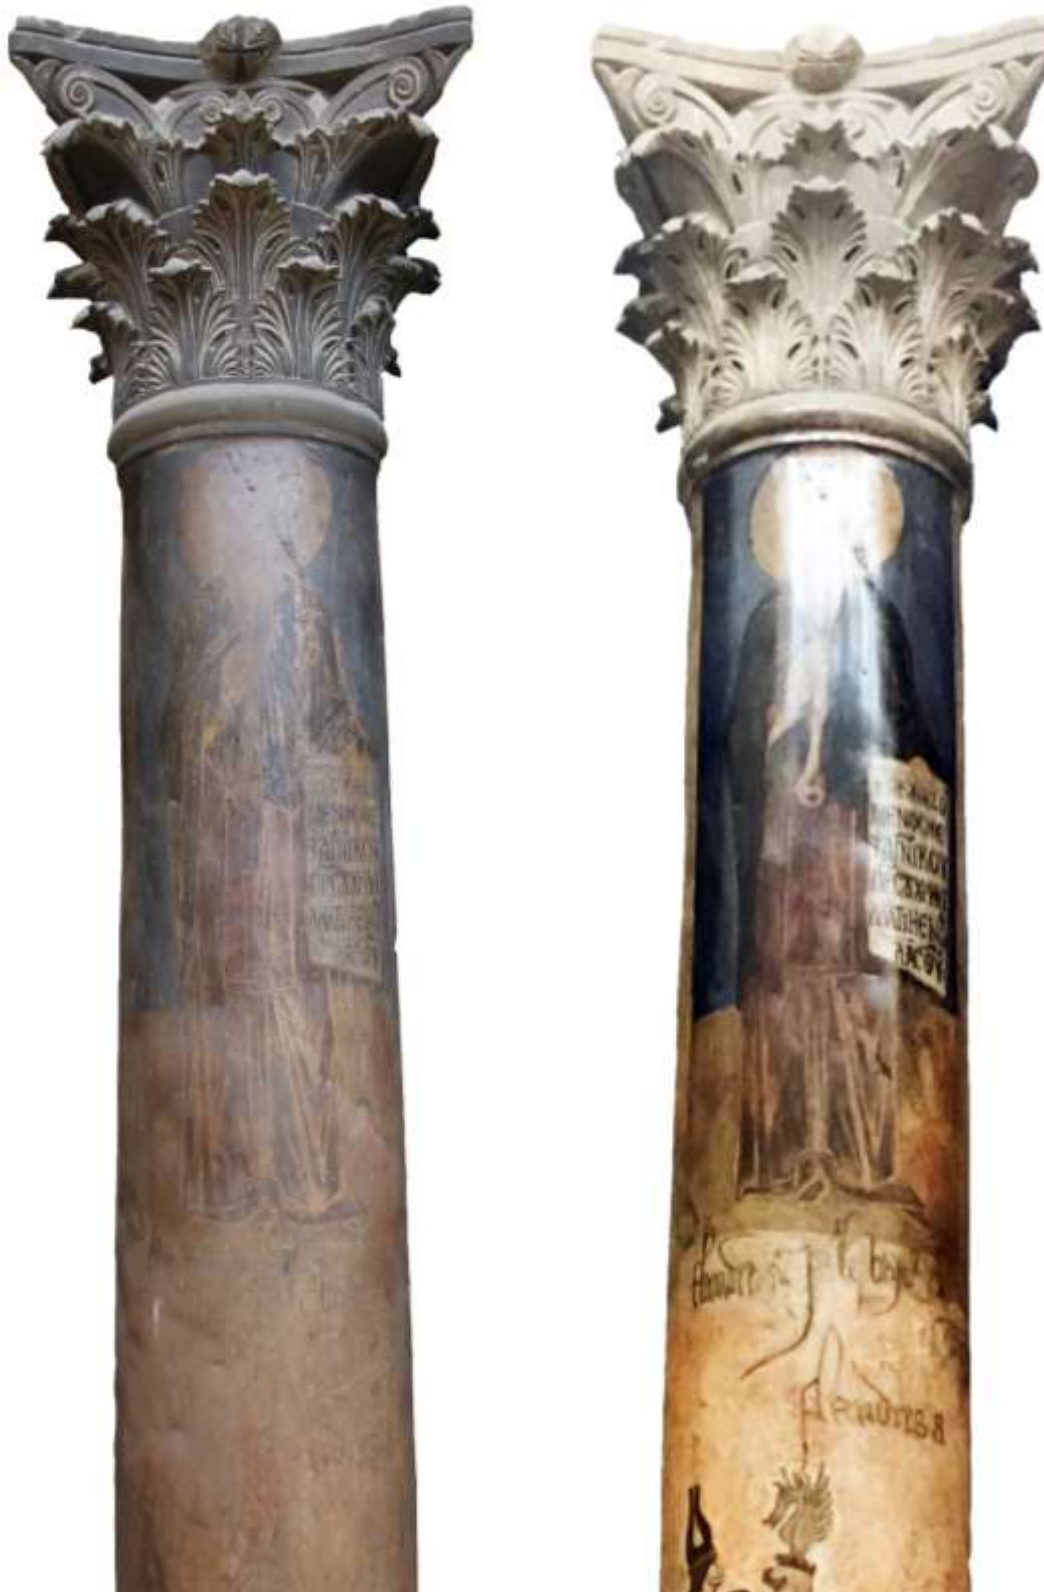
One of the columns before and after restoration

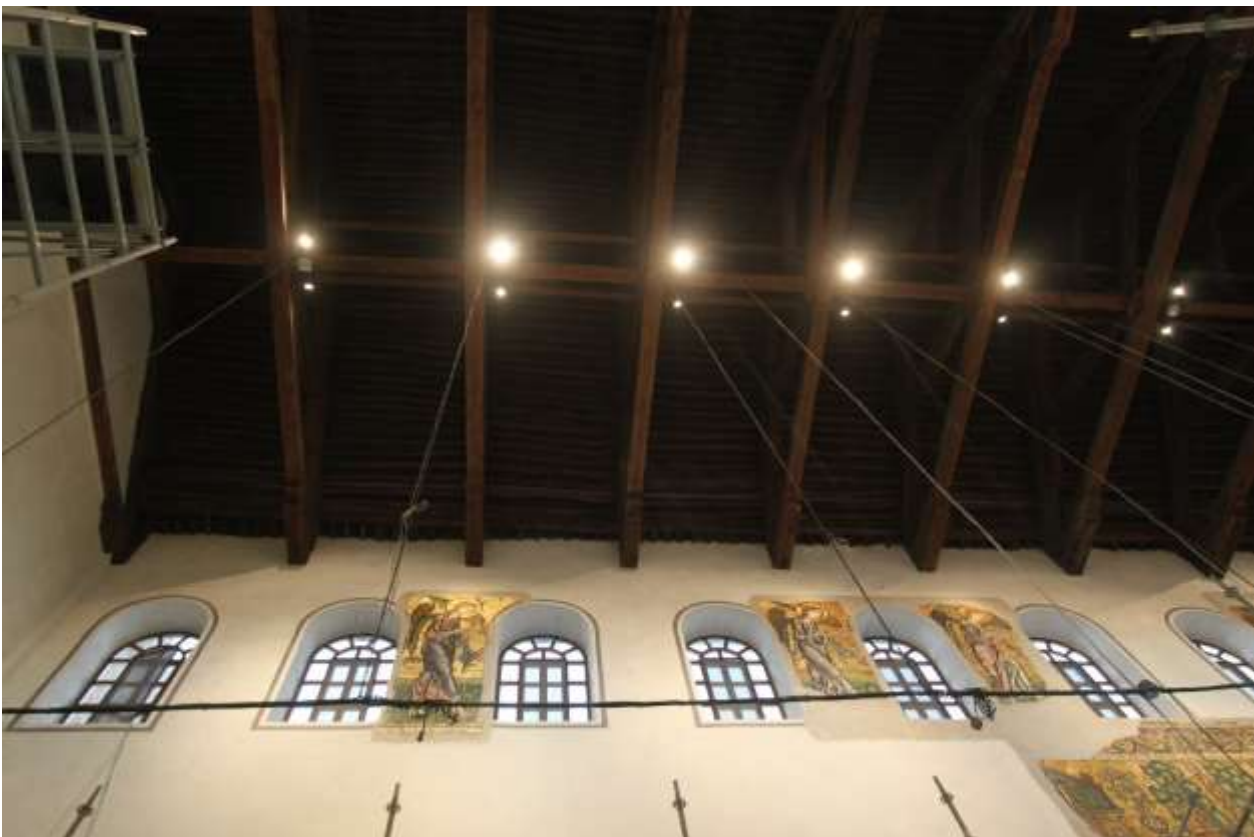
*The new lighting system at the central nave*

The electrical works include the installation of the smoke detection and the lighting systems. The works were completed by the end of December 2017.

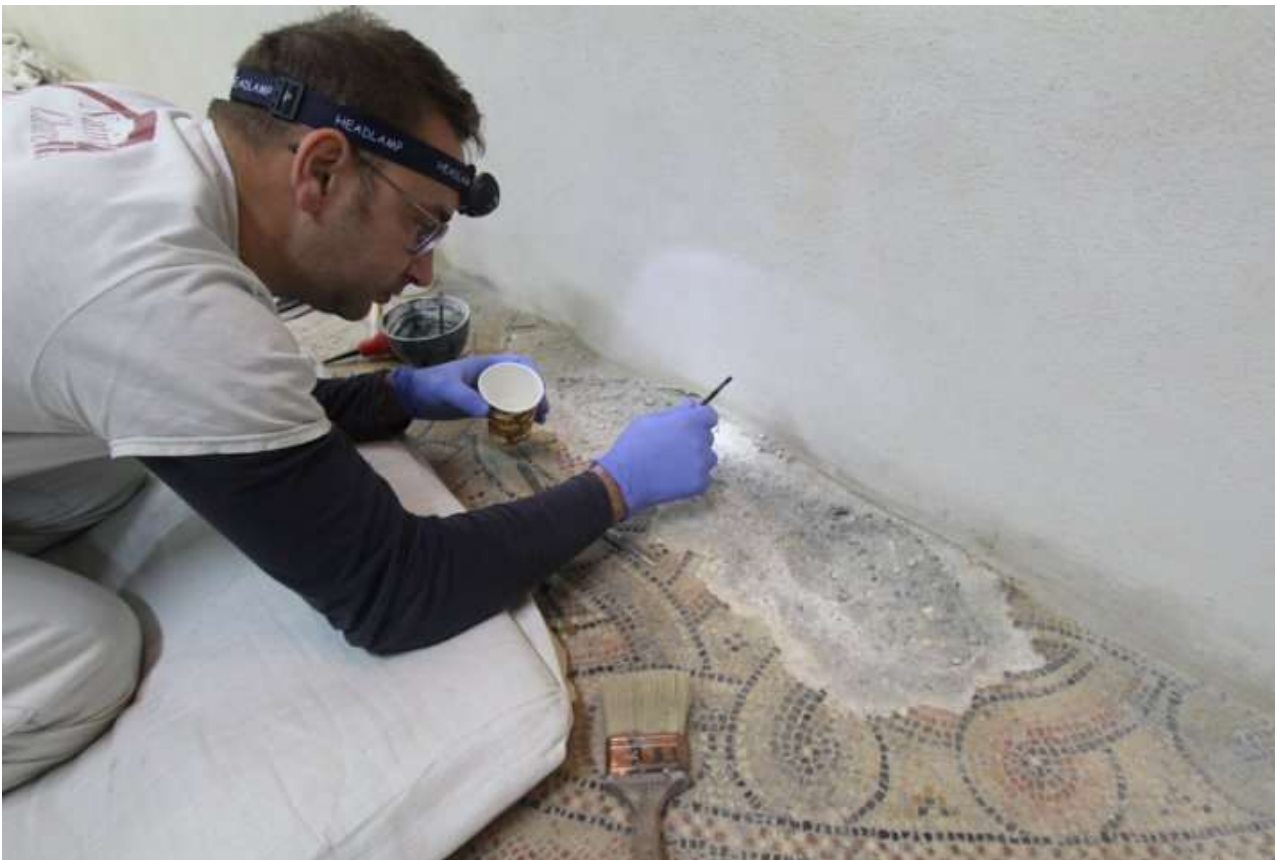
Restoration and consolidation

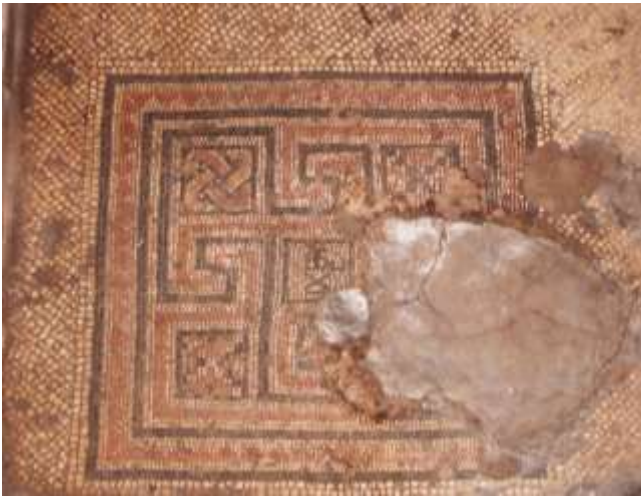
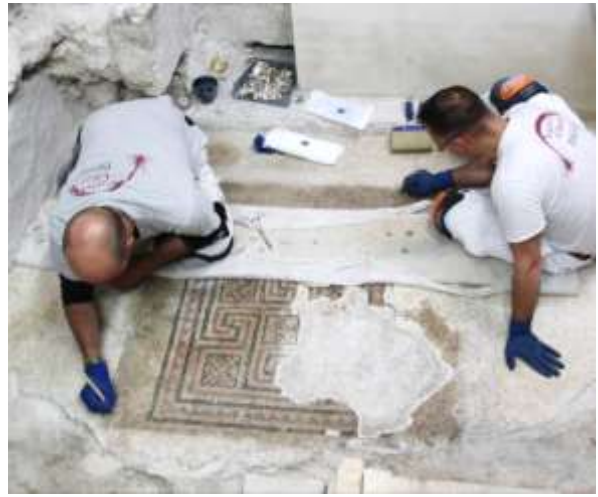
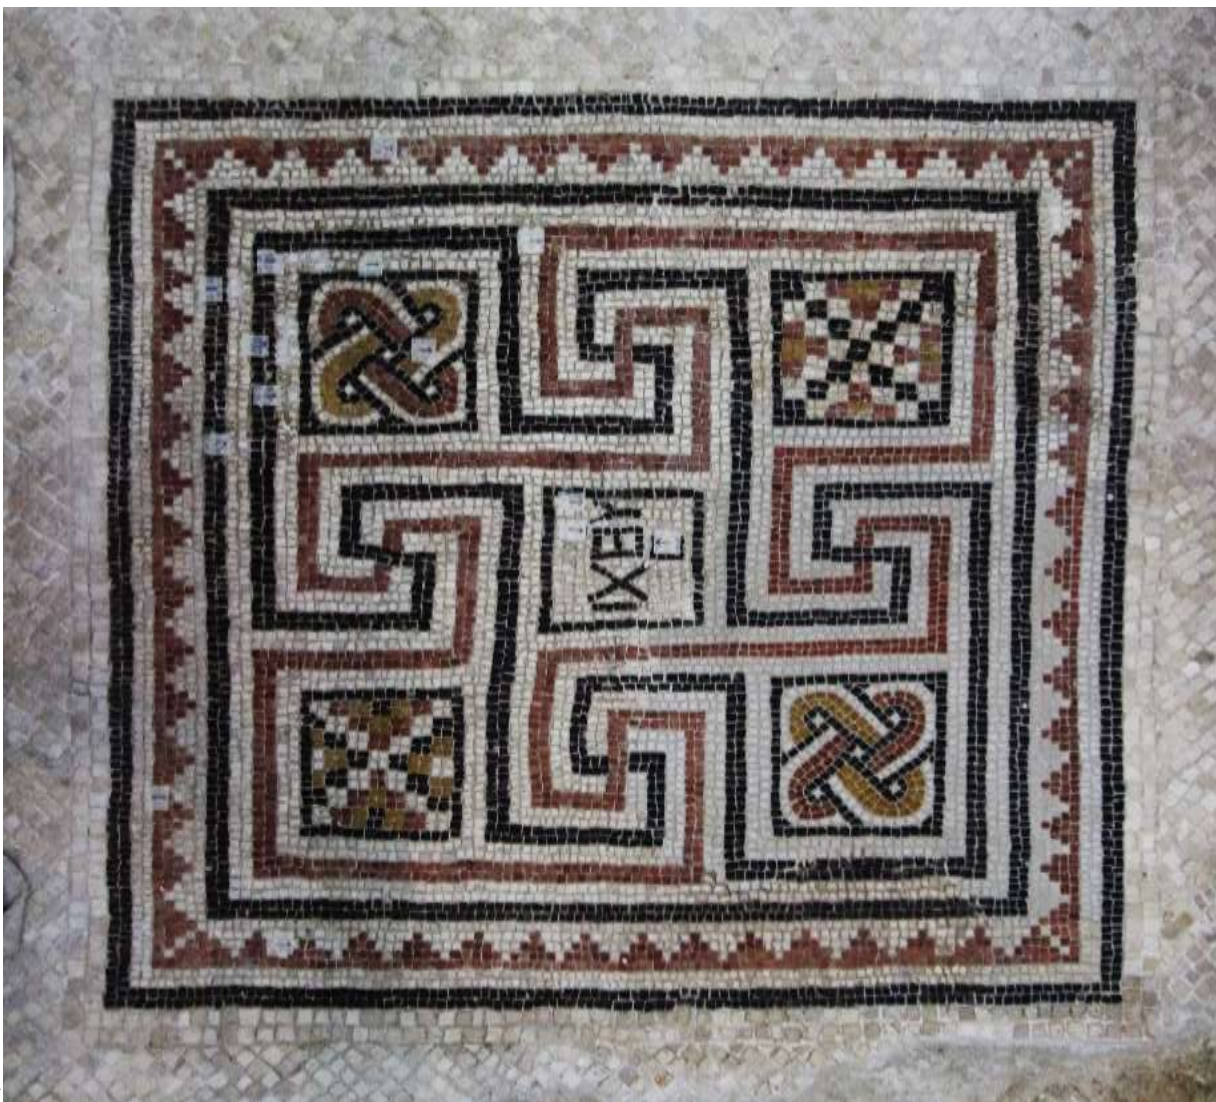
Floor mosaic: Area #1 – Before, during and after restoration

According to the available funds, in the mid of January 2018, the presidential Committee has authorized the restoration of part of the floor mosaic area (area #1, 2, 3, 4, 5 and 10). Area #1 located at the Central Nave beside the Bema, Area 2 & 10 located at Transept North beside the stairs leading to the Bema while areas 3, 4 and 5 located at the North side of the Central nave. The restoration of all these areas was completed in December 2018.

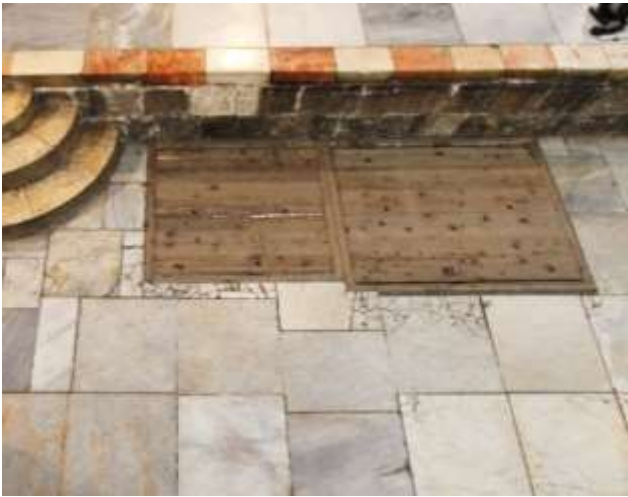
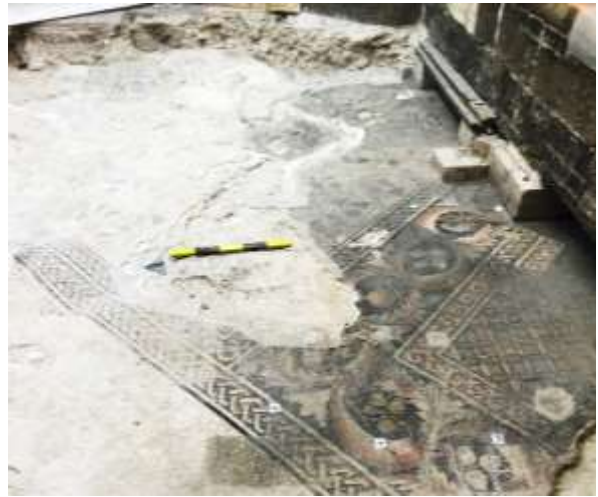
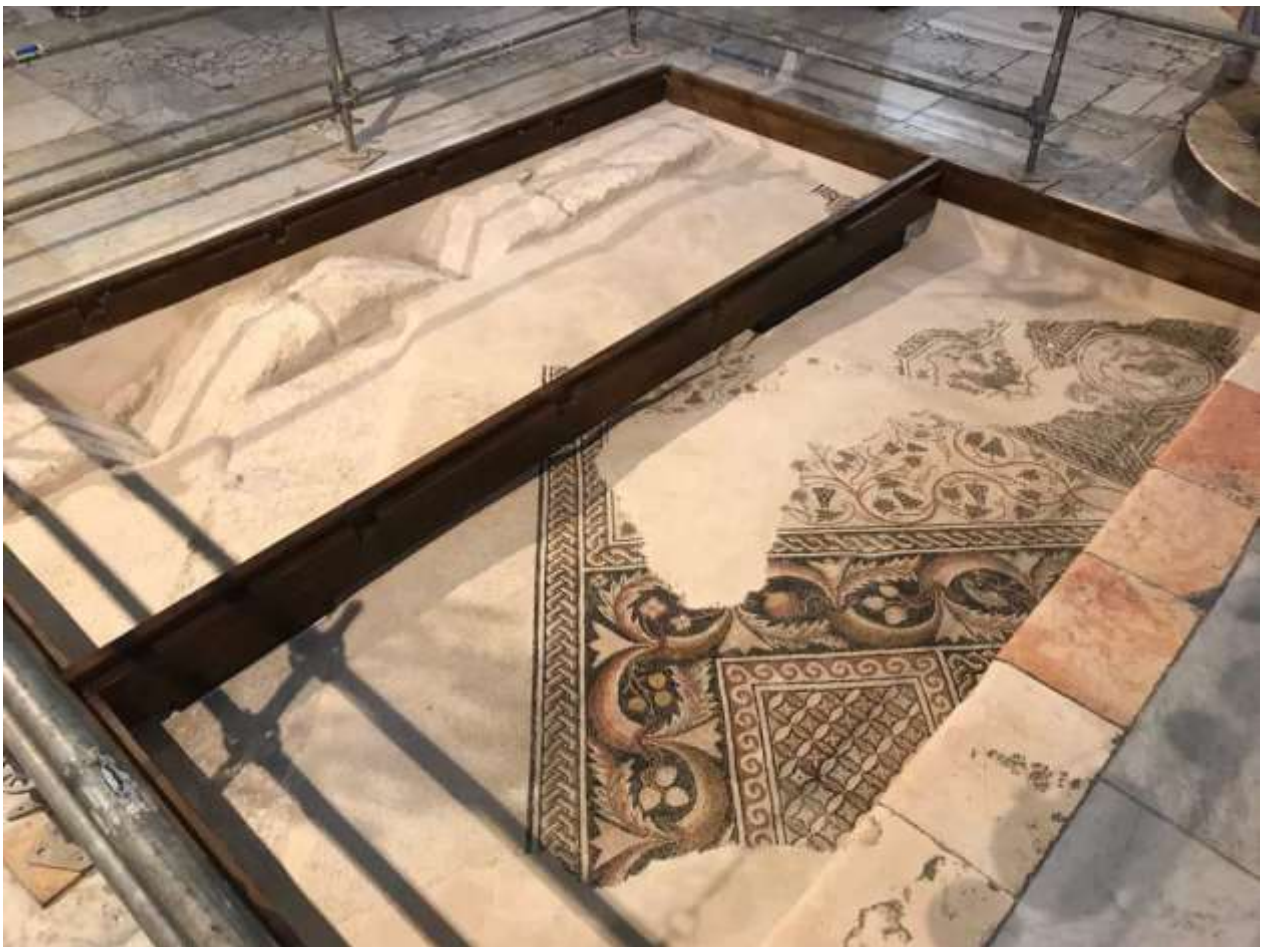
Floor mosaic: Area #2 – Before, during and after restoration

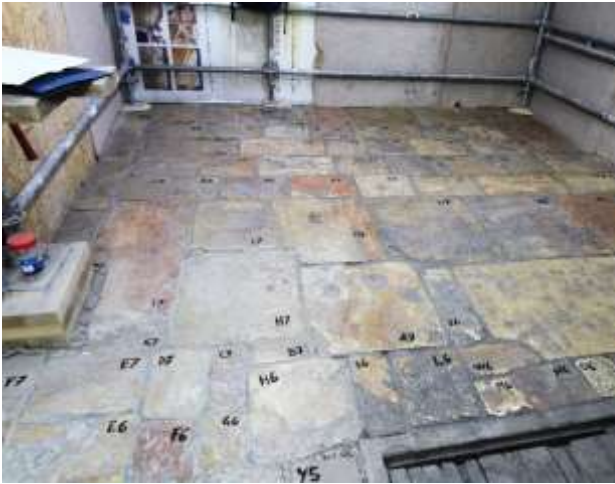
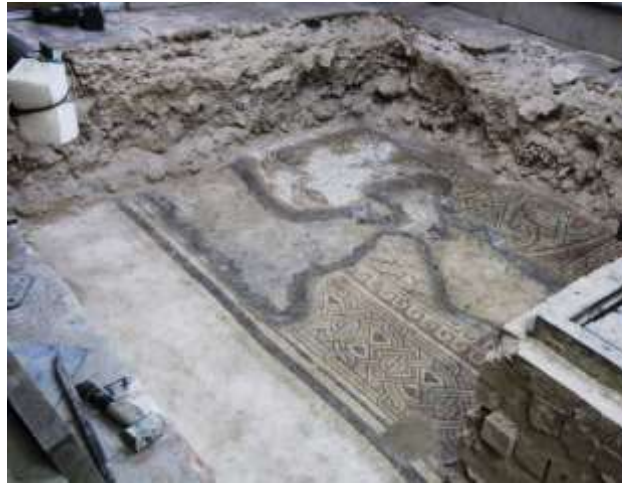
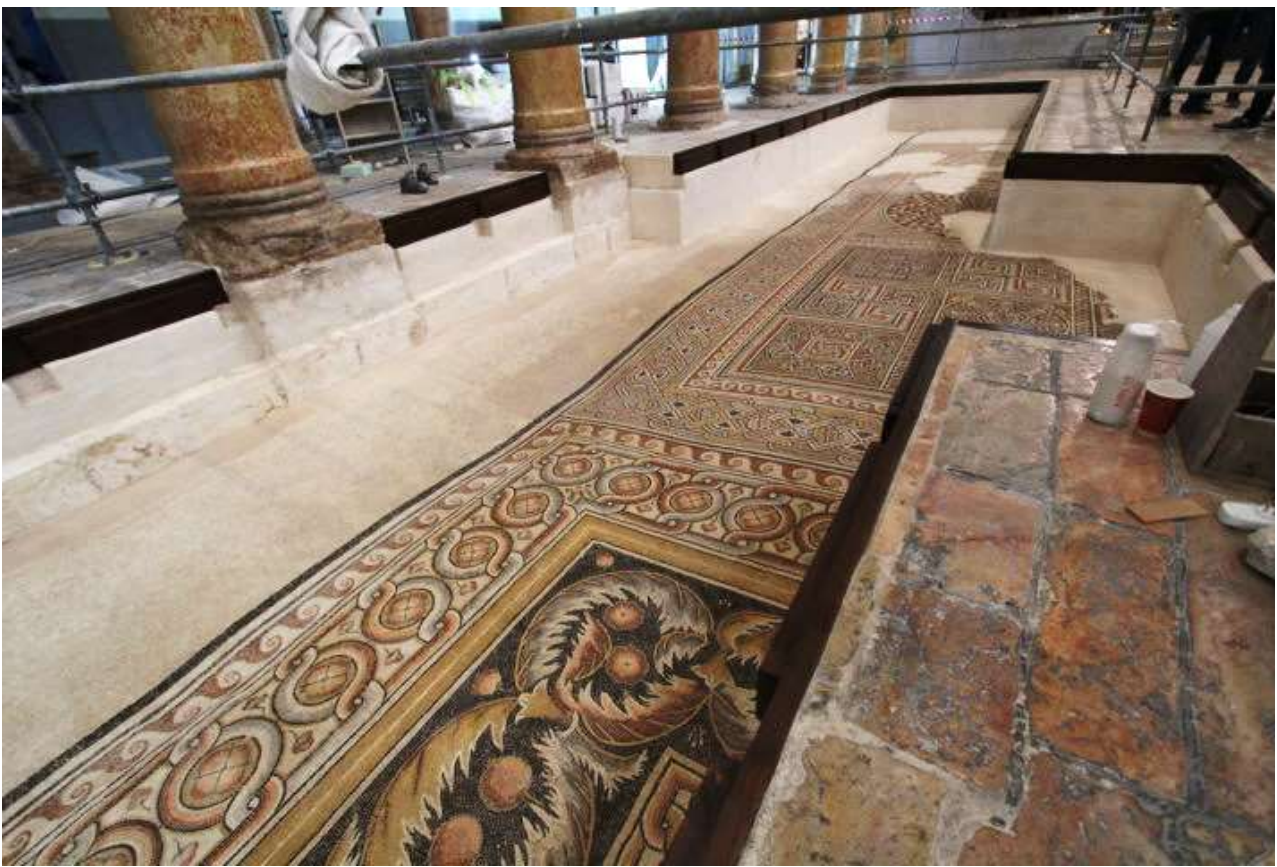
Floor mosaic: Area # 3, 4 & 5– Before, during and after restoration

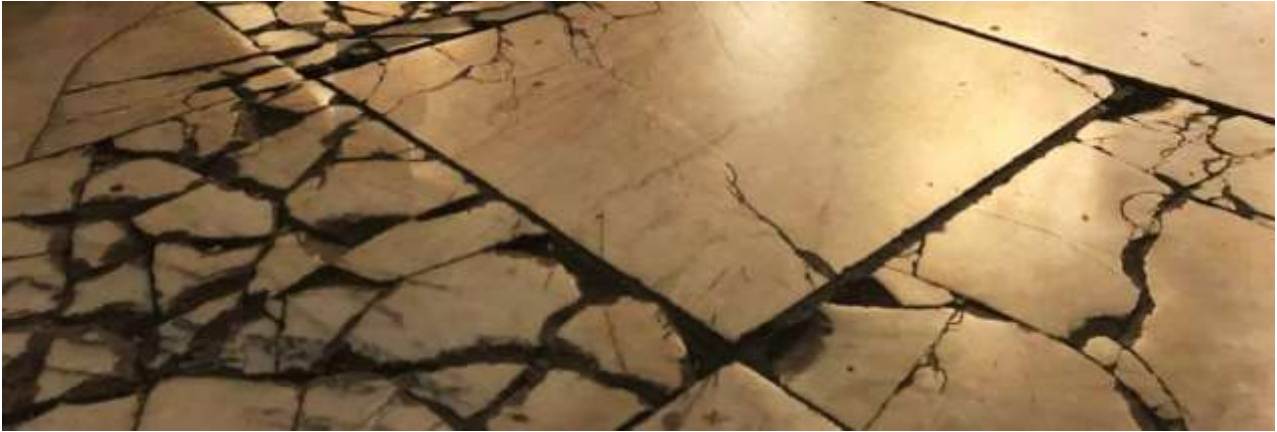
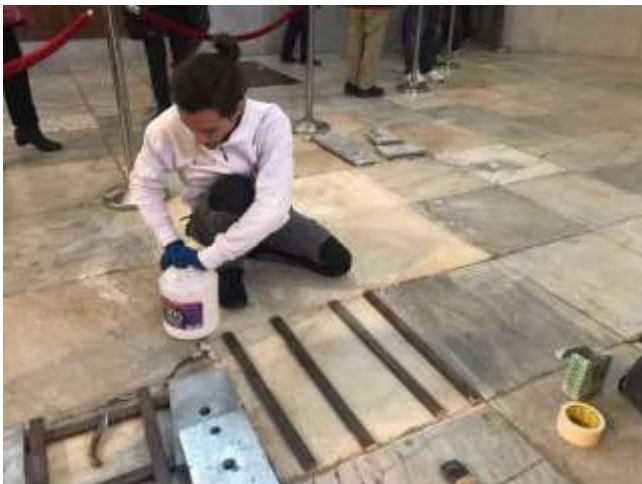
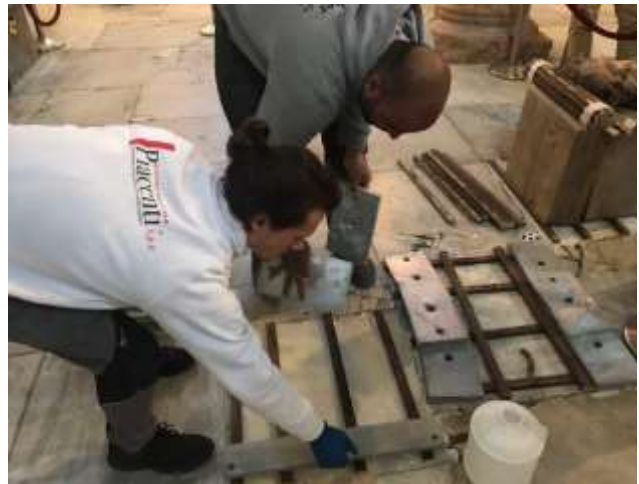
According to the available funds, During February 2019, the presidential Committee authorized the restoration of the most damaged marble tiling located at transept north. The general scope of work is to restore, protect and preserve as much as possible the existing tiles by restoring the cracks and other medium damages while some is completely damaged that will be replaced with new suitable and compatible tiles. The works started on February 5, 2019 and planned to be completed by the end of June 2019.

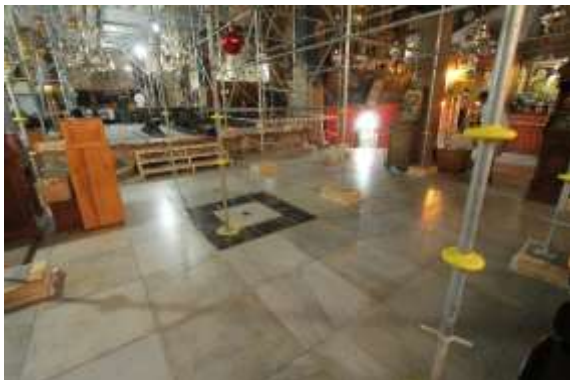
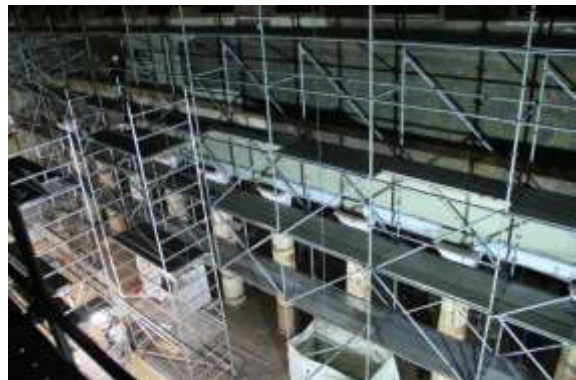
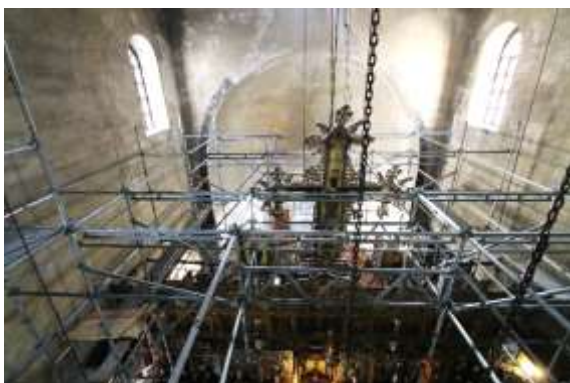
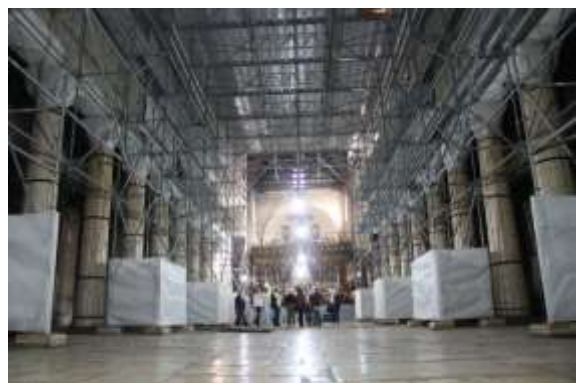
It's worth mentioning that before the erection of the scaffolding system, intensive studies, calculations and analysis were made, checked and approved to make sure that the loads transferred to the Church stone flooring are within the permissible limits and taking into consideration the location of the Nativity Grotto and cavities.

Before starting the assembly, work for the scaffolding inside the church the contractor protected the columns of the church using a special layer of geotextile with vertical wooden rods to achieve the maximum protection level. Prior protection works, dilapidation survey was performed to capture all existing conditions of the church elements including columns, floor, walls, mosaics, paints ... etc by high quality still photos and video so that existing site condition can be easily and accurately defined and determined.

By the completion of the scaffolding platform at the windows level, the contractor was able to start installing temporary protection system for the wall mosaic using special materials and wooden cover to avoid any damage during the restoration works.

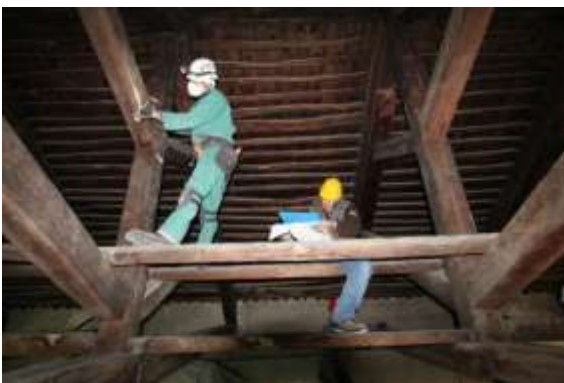
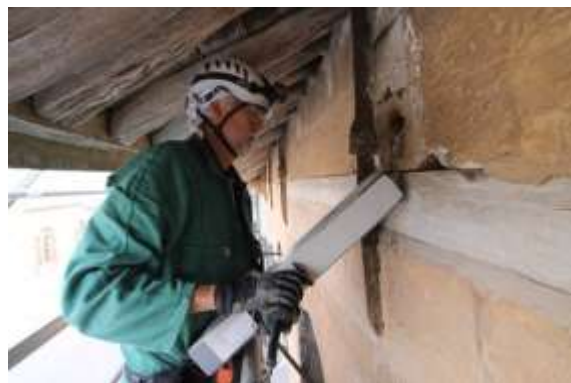
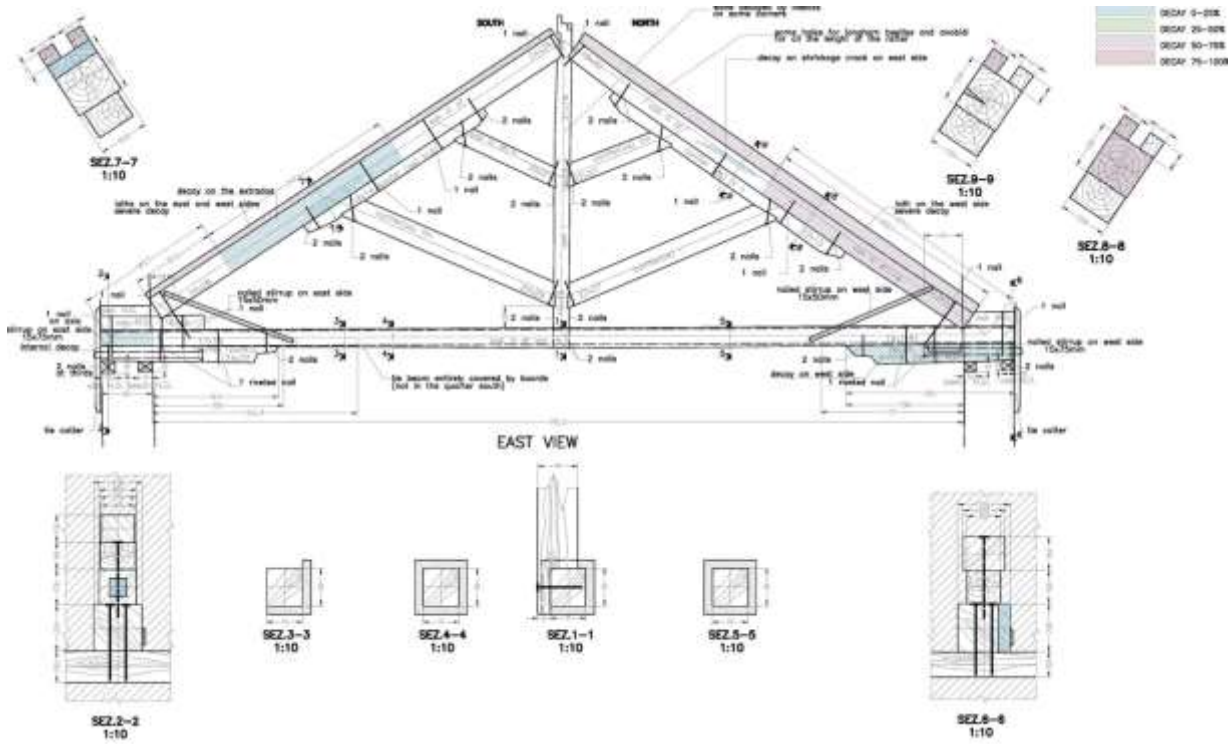
## 8 DETAILED WOOD EVALUATION:

Starting from December 2, 2013 until December 11, 2013 and from January 27, 2014 until February 16, 2014 wood experts have evaluated the current condition of the existing wooden structure supporting the roof and performed several non-destructive tests for the central nave and the aisles to provide information regarding geometry, dimensions, characteristics of connections, wood species, humidity and class of mechanical quality of the wood to prepare the design and shop drawings with respect to the tender documents. The same evaluation process onsite for the transept area and the Altar has started again since 2 June 2014 and completed on July 6, 2014. All the information, notes, observations and tests results were the reference to prepare the design and shop drawings for each truss.

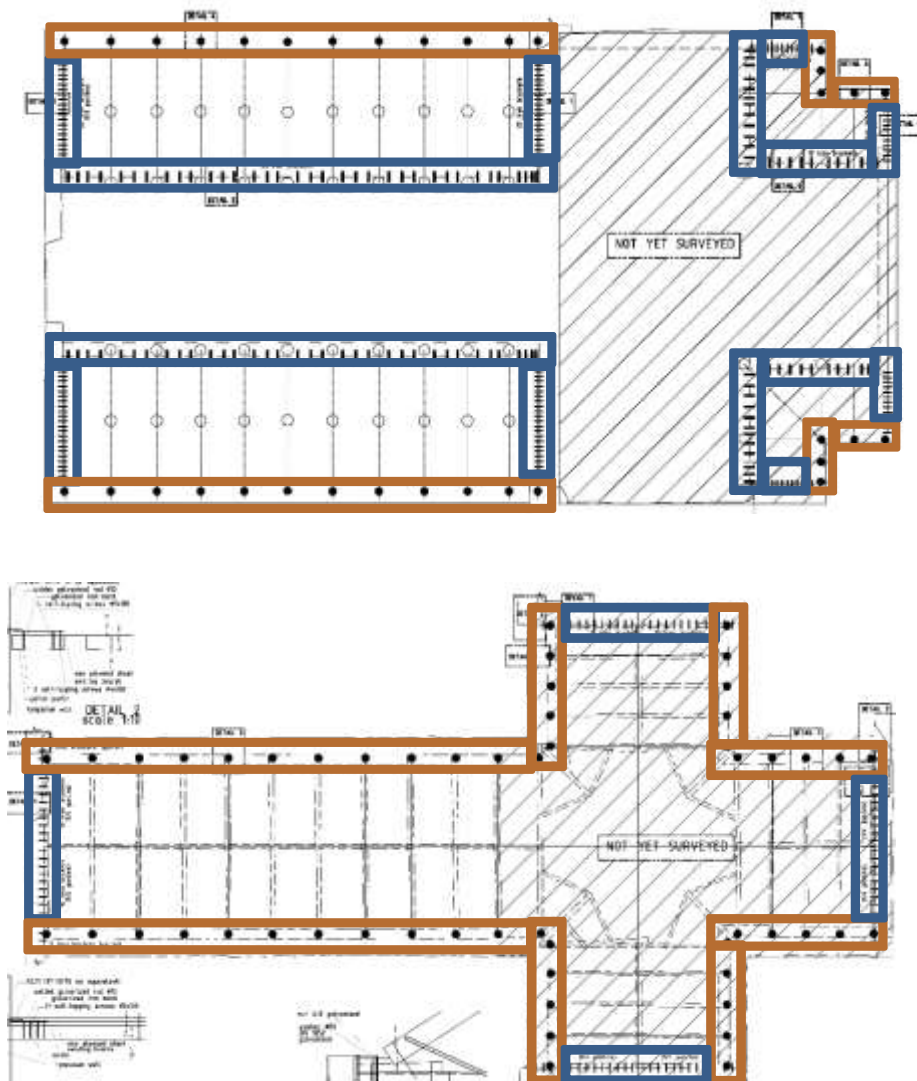
## 11 SEISMIC REINFORCEMENT

The restoration project is not only limited to the repair and restoration of the roof but also includes the seismic performance improvement since Bethlehem is in a seismic area and therefore there was also a danger due to the seismic vulnerability of the Church. Accordingly, roof-masonry connectors were required to be installed to connect the roof structure to the masonry wall in order to transfer the seismic load. The design included two types of seismic connectors: 1) Steel bars connectors to transfer the seismic loads from the end of trusses to the walls 2) Purlins connectors' that will connect the roof structure especially the purlins to the masonry walls. The contractor has completed the installation of the purlins connectors for the entire roof and the required steel bars insertion for all trusses.

Completed purlins seismic connectors

Completed seismic bars insertion

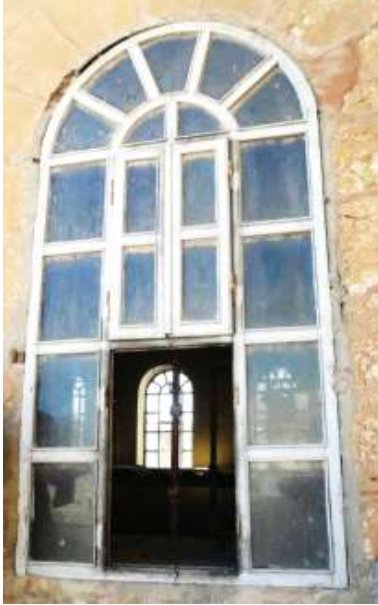
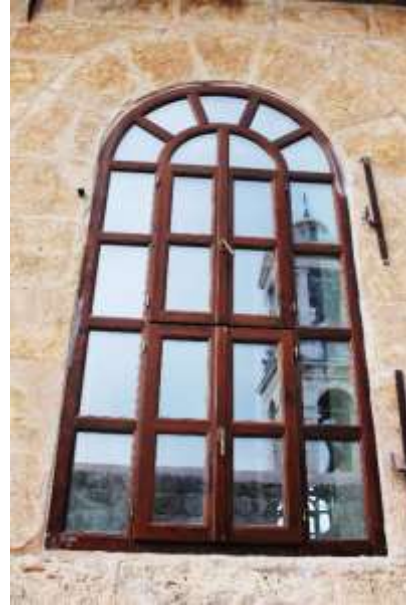
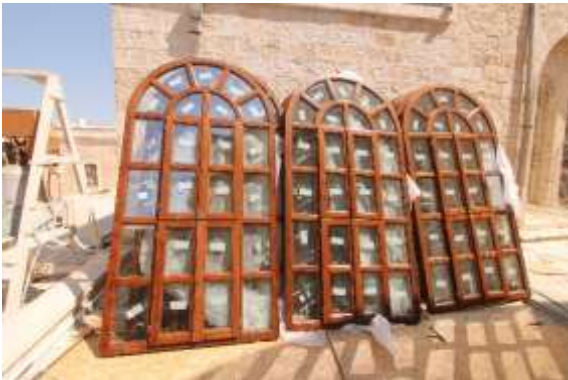
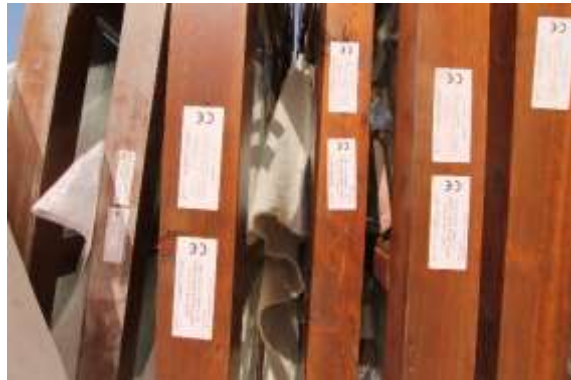
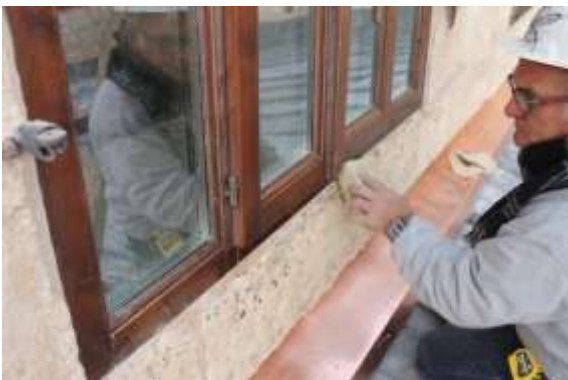
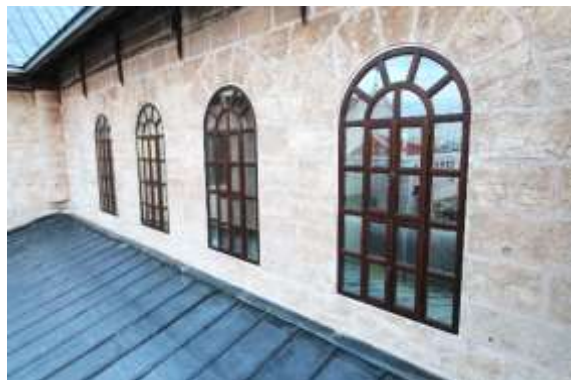
The original contract (phase I) includes the replacement of existing damaged and decayed wooden windows with new cypress wood windows with low emissivity double glazing and special specification to reduce the lighting in the church and to be more suitable for the mosaic, paintings and other delicate decorative surfaces. The new windows have been fabricated in Italy and brought to the site and 42 windows were already installed.
