# The Palestinian Presidential Committee for the Restoration of the Church of the Nativity

*Contract Number: NCRW-PI-13/1*

## Brief Construction Progress Report

September 15, 2013 – May 23, 2019

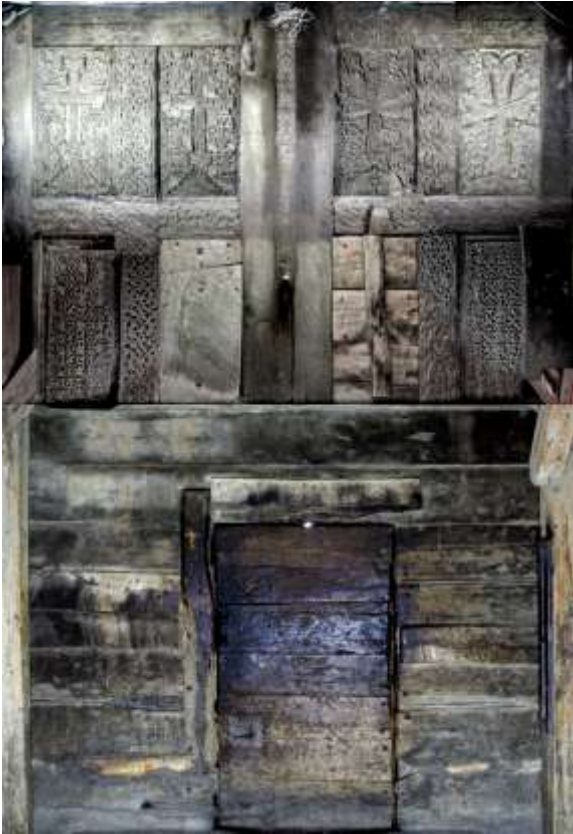
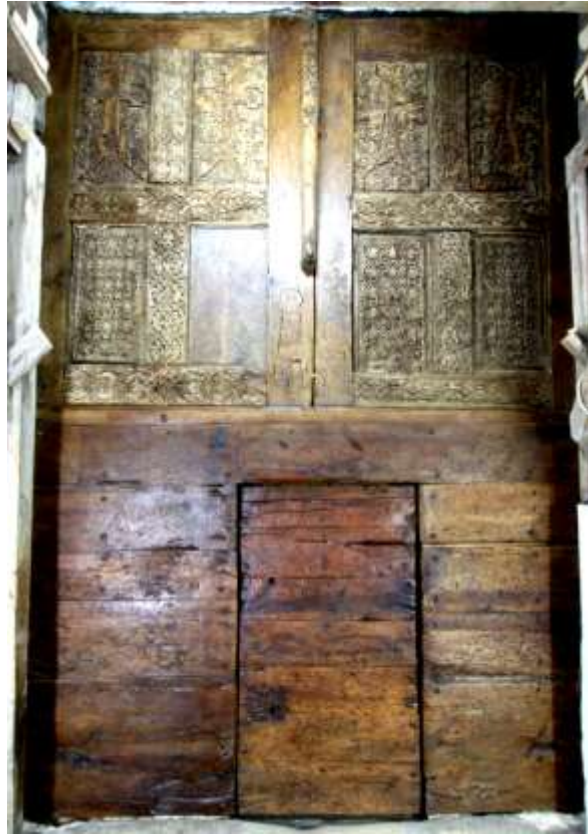
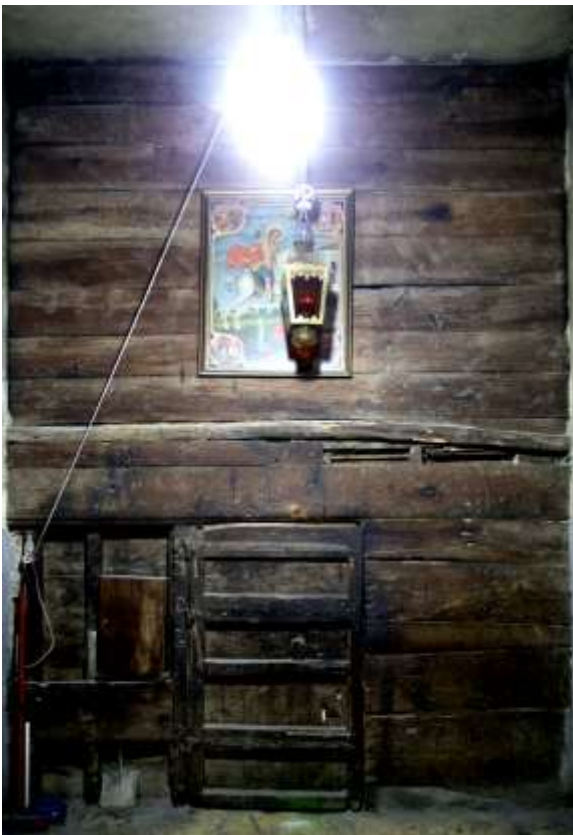
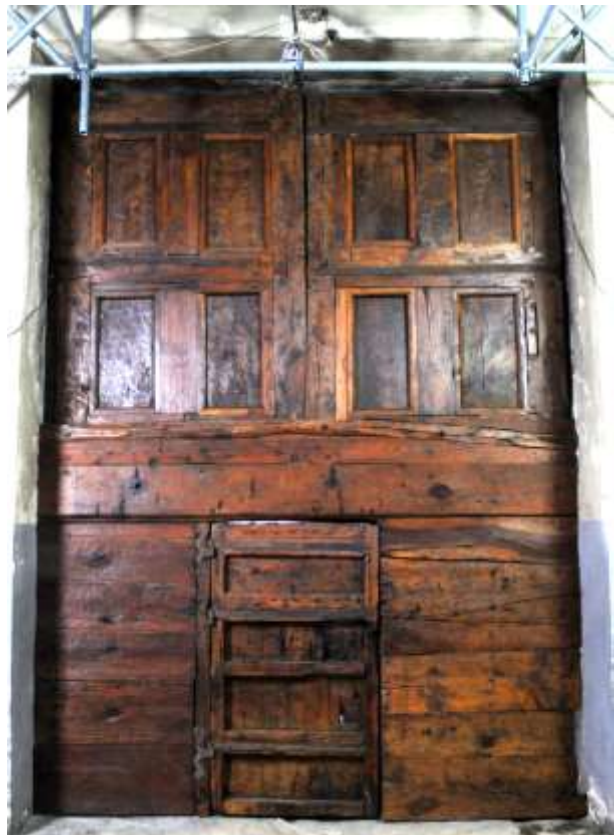
During the restoration works, it was found that the upper part of the door from the eastern side has wooden boards that hide the original wooden door, while the western part has also some part that have been uncovered to show the original carving art work. After the completion of the necessary restoration and consolidation works in December 2014, the visitors and pilgrims can see the original door and the wood carving art on the other side.

*The two sides of the narthex door before and after restoration works*

The restoration works for the narthex eastern wooden door has started in September 2014 by erecting a suitable scaffolding system and performing high-resolution digital photographic documentation and diagnostic research. Then followed with a careful consolidation and treatment process by wood restoration specialists.

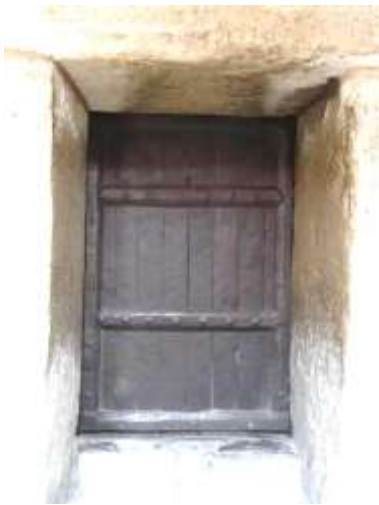
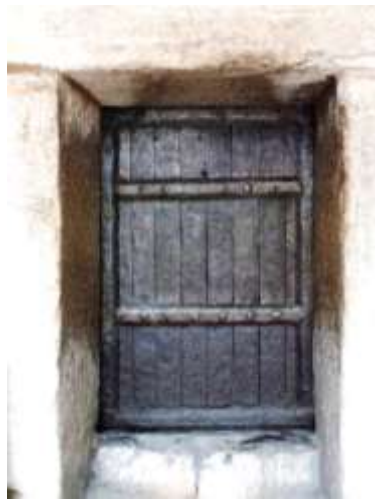
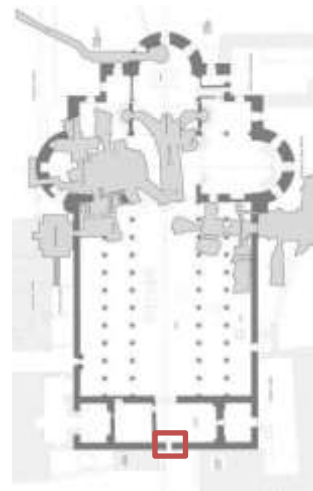
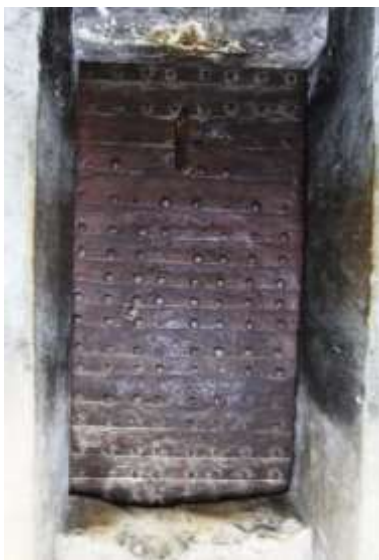
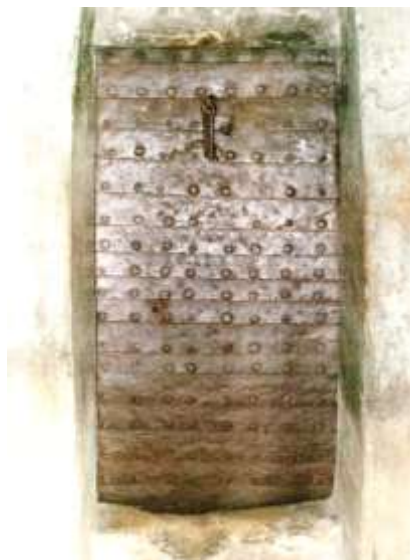
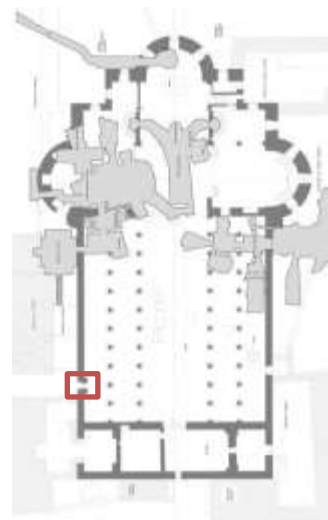
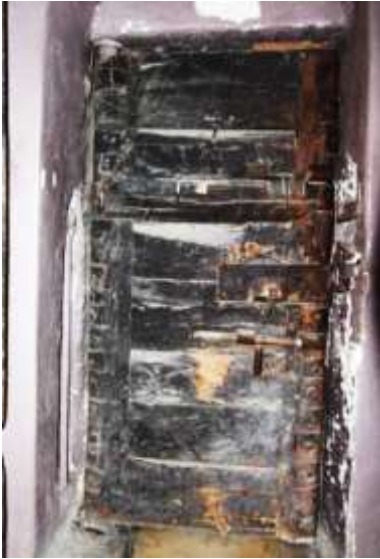
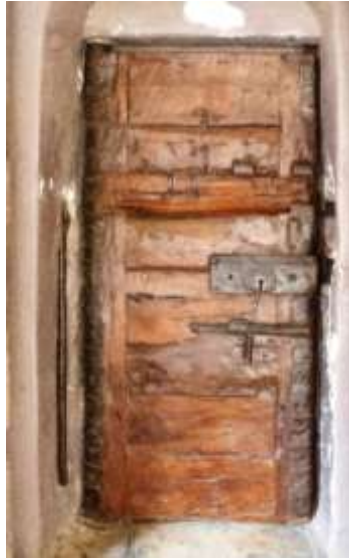
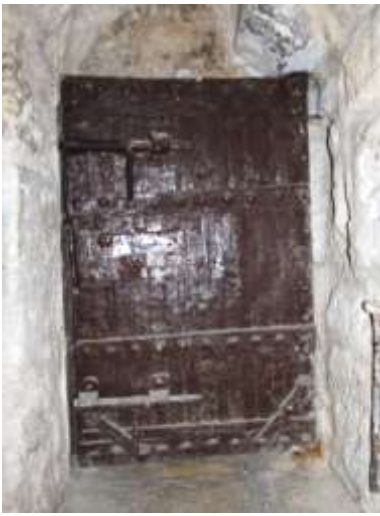
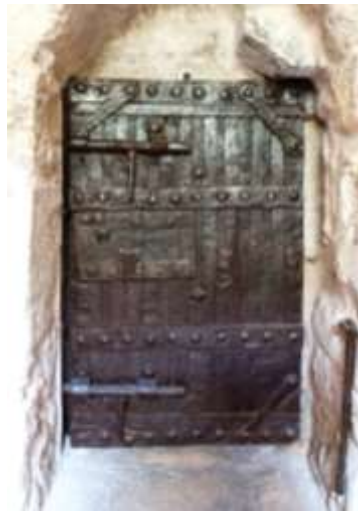
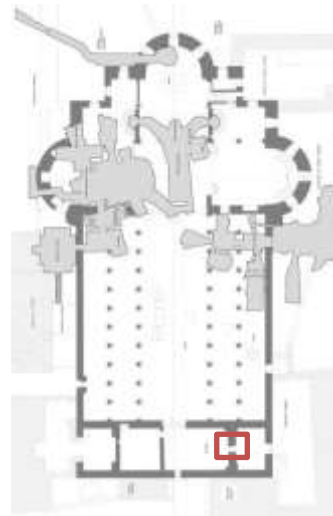
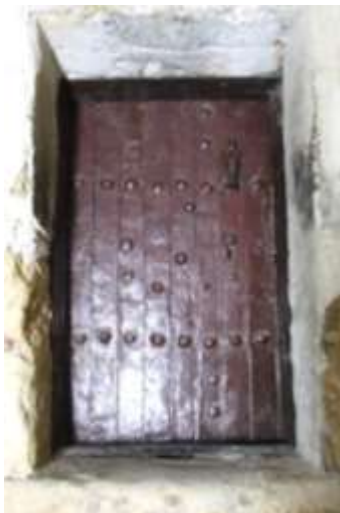
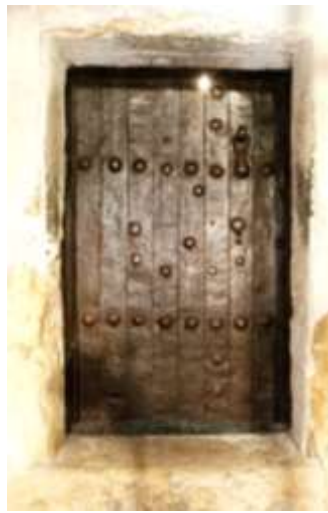
The works includes the restoration of the humility iron door; narthex southern iron door; lateral nave northern iron-wooden door; lateral nave southern iron door and lateral nave north iron window. The surfaces show in many cases erosions and exfoliations due to the oxidation of the iron and degradation of the wooden elements of the lateral nave northern door.

The restoration process included accurate photographic documentation, before, during and after restoration, tests execution for the various phases of the operation, stratigraphic tests for identification of the finishing coats sequence of the varnishes, mechanical removal of incoherent deposits, chemical removal of superficial coherent deposits, treatment aimed to stop the oxidation and to protect metallic surfaces, visual and aesthetic interference reduction of the surfaces and protective surface treatment as final operation of the restoration. The restoration works were completed in March 2015.

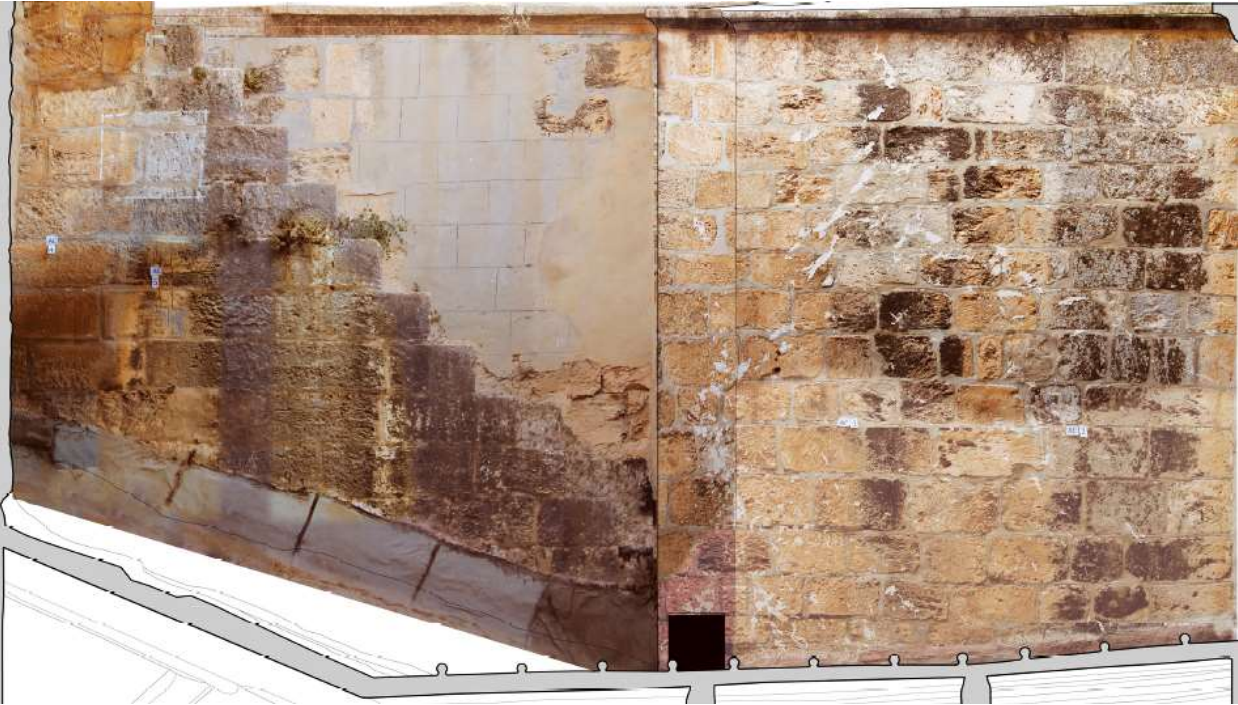
Northern corner – Before restoration

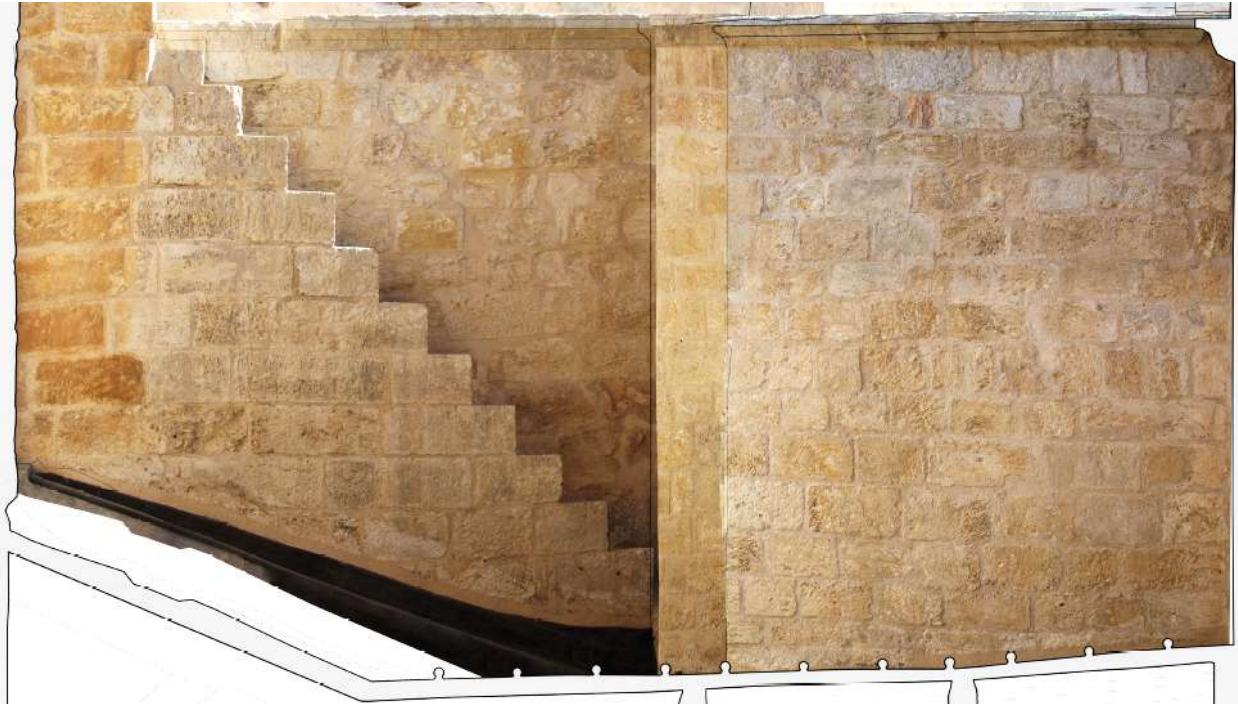
Northern corner – After restoration

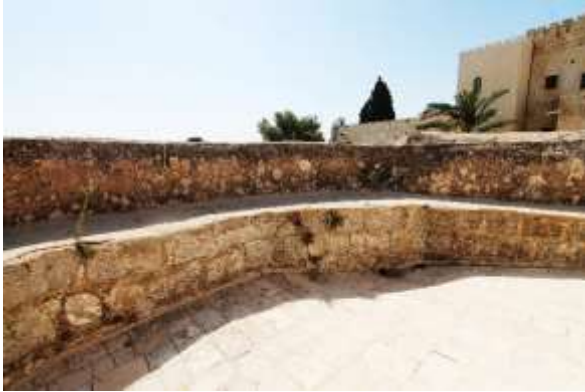
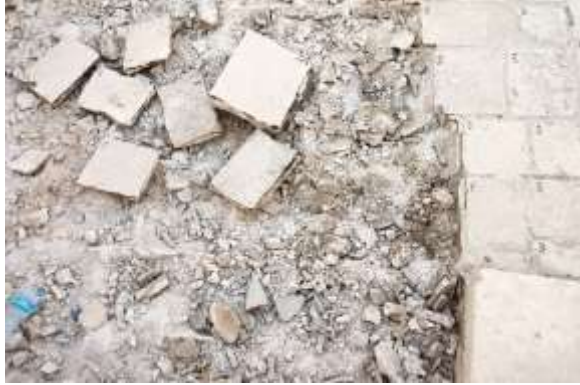
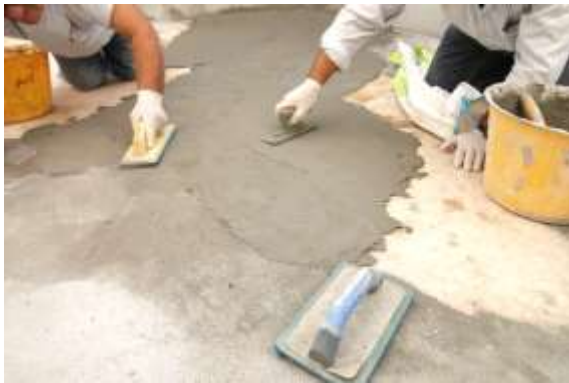
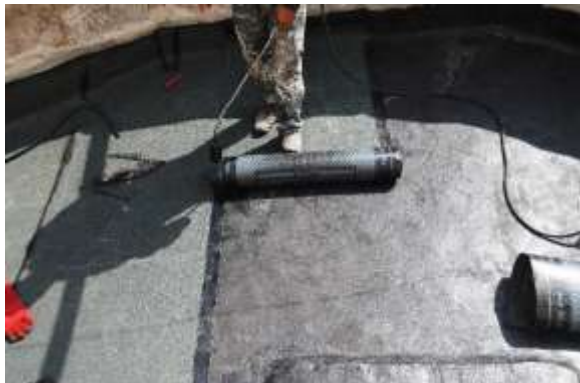
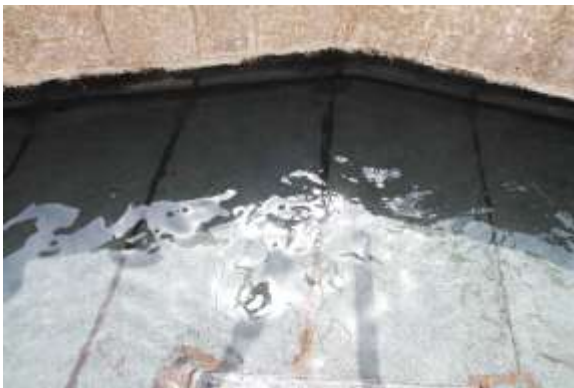
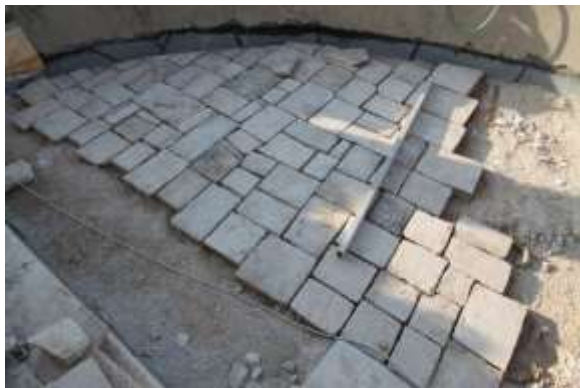
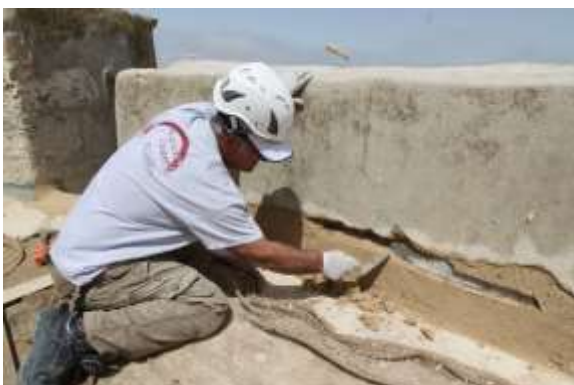
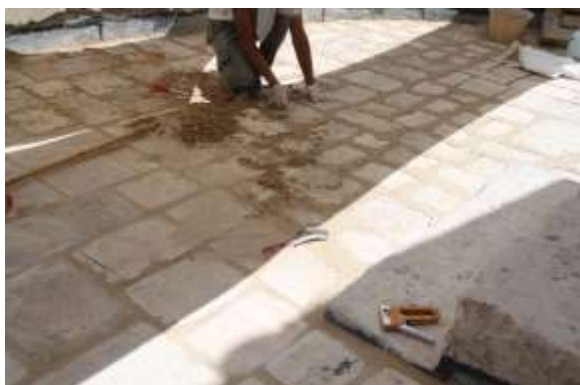
The Presidential Committee has authorized the works on the three terraces (Transept North, Transept South and the Apse), the work aims to insure a perfect waterproofing system to prevent any water leakage that could reach the recently restored plaster inside the church. The works included the dismantling of the existing stone tiles after numbering preparing for re-installation in the same location after the completion of the waterproofing layers and the restoration of the external plastering of the parapets. The works were completed by the middle of June 2016.

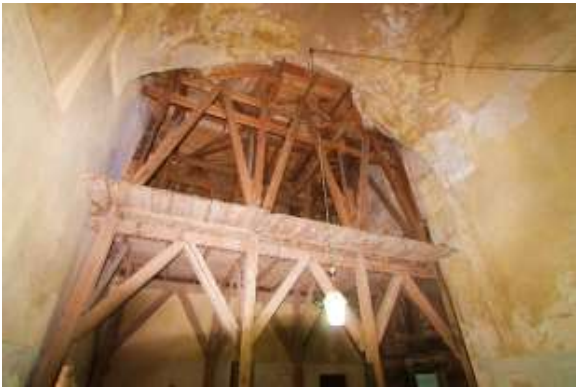
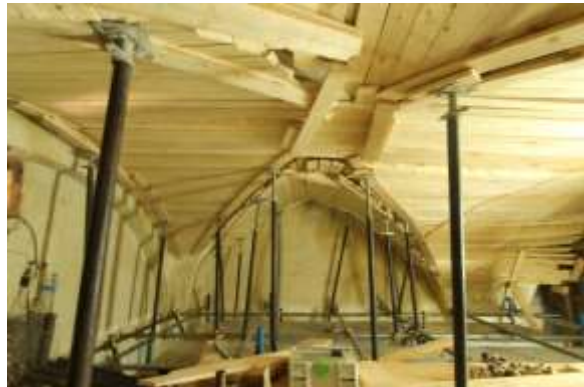
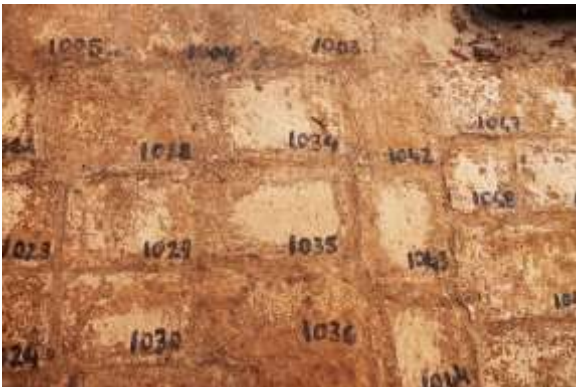
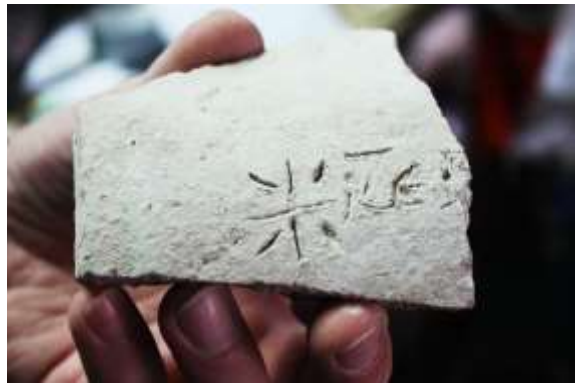
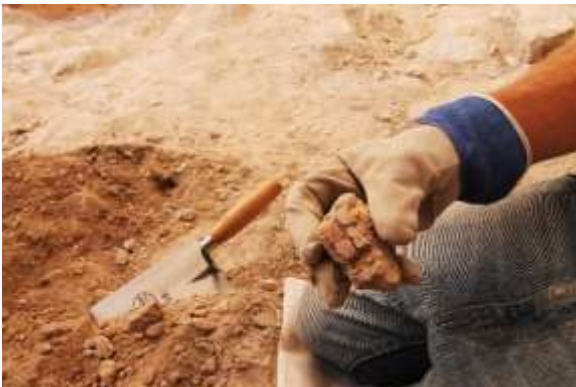
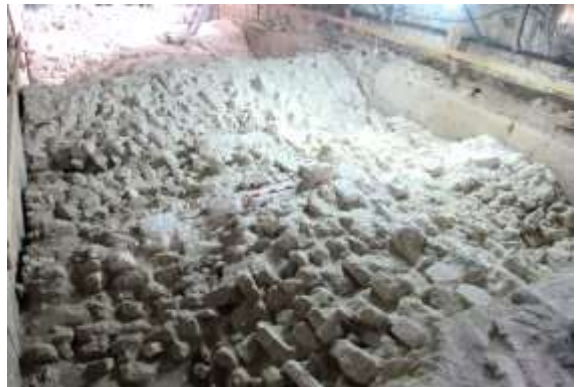
In accordance with the list of priority restoration works, additional works #1 were awarded to the contractor on March 28, 2014 which includes the restoration of the narthex and the narthex eastern wooden door. The works has started after installing the required temporary roof and the necessary propping system from below. The archeological excavations on the damaged vault was started after numbering and dismantling of the narthex roof stone tiling. All the works were performed under a comprehensive documentation system and archeological stratification and analysis.

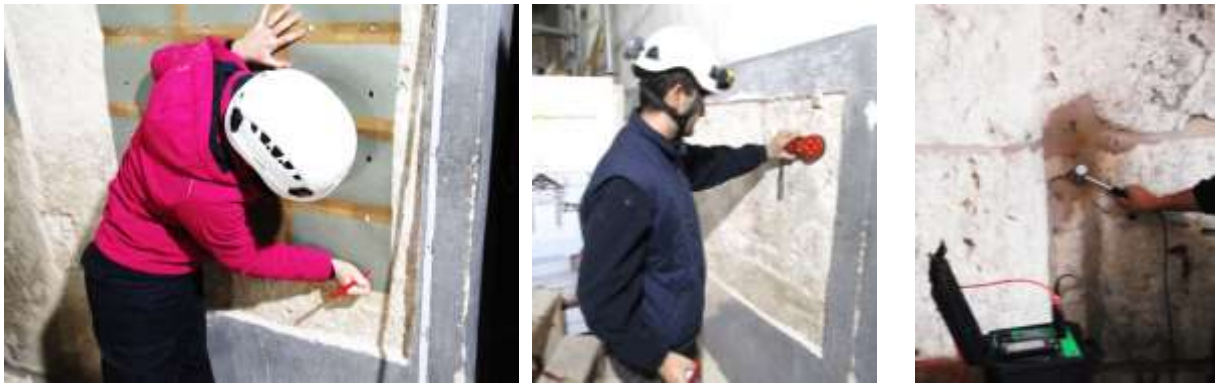
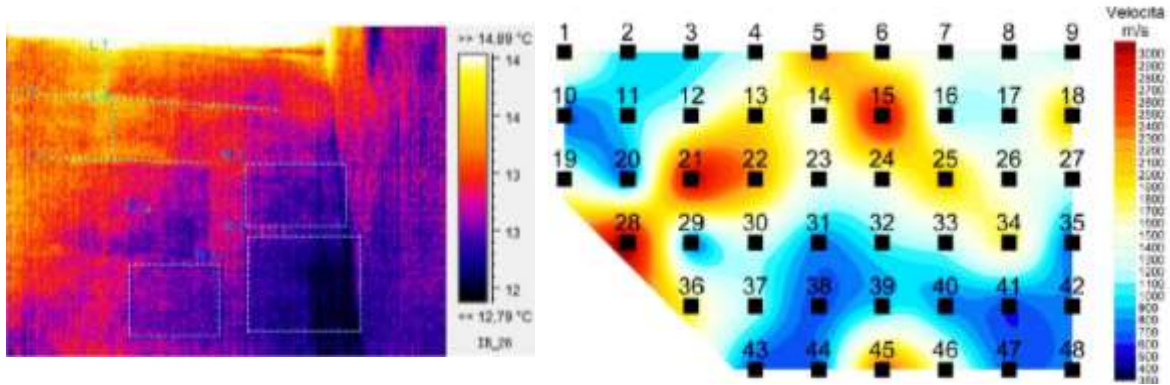
Additional nondestructive tests and analysis were also needed for the same reason including sonic test, microscopic analysis, thermographic survey and core test to realize the details of the structural system and the components of the different structural elements which have been carried out during January 2015.

Sonic velocities distribution for transparency

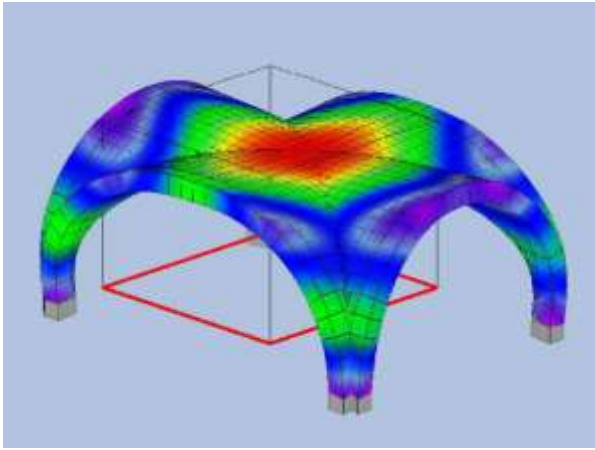
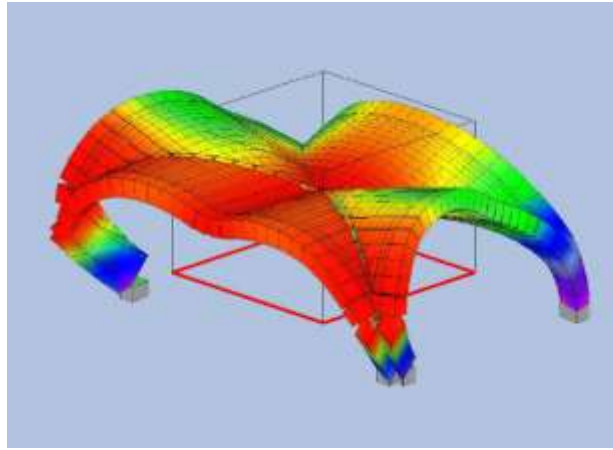
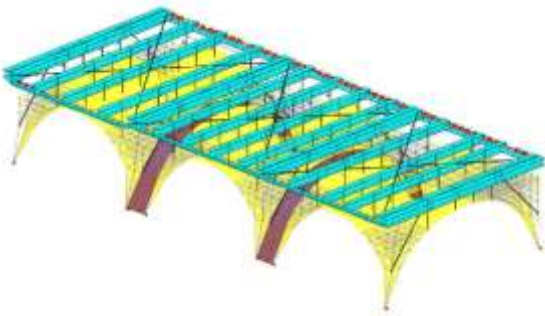
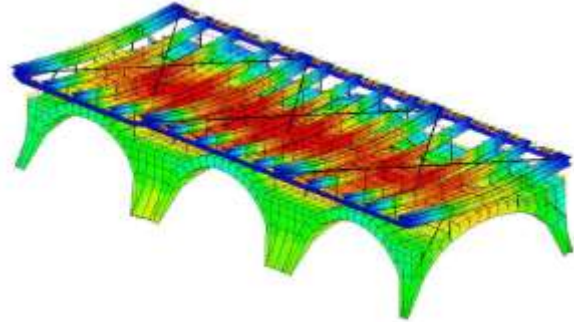
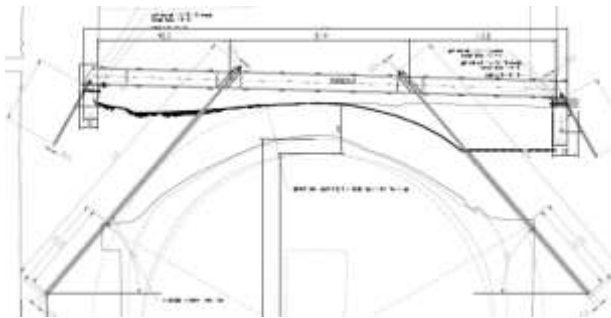
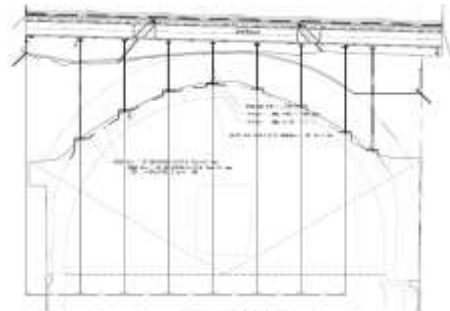
Based on the results of these tests, the model, structural analysis and the shop drawings were adjusted and submitted with the financial offer for review and approval.

The new technical and financial offers were studied carefully and approved on June 6, 2015. The consolidation works started on June 19, 2015 and completed in April 2016 which includes the installation of the supporting steel structure on the extrados of the narthex vaults, the installation of the corrugated sheets with the steel reinforcement, casting 10 cm of concrete slab, casting the slopping foamed concrete, installing two layers of bituminous membrane and installing back the reserved dismantled old tiles.

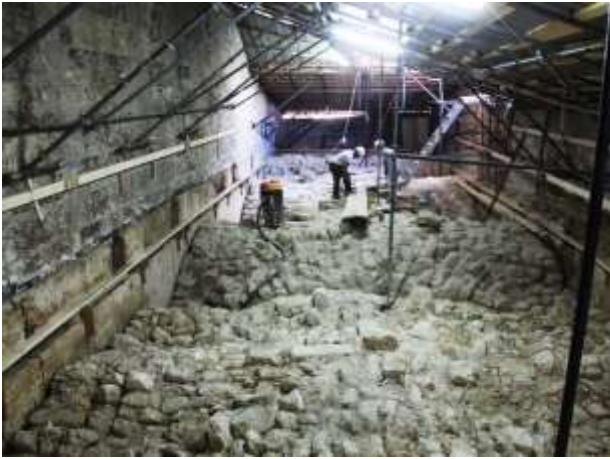
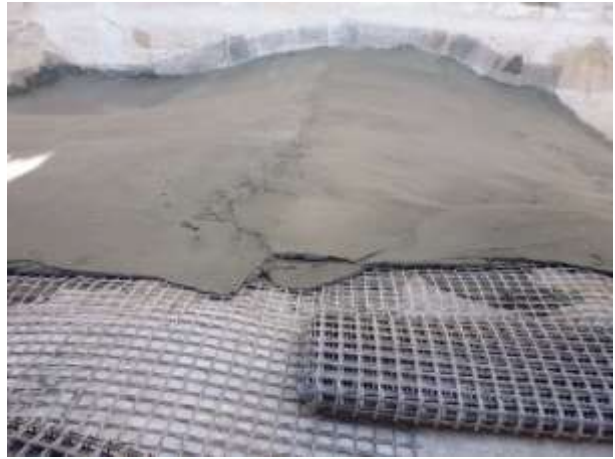
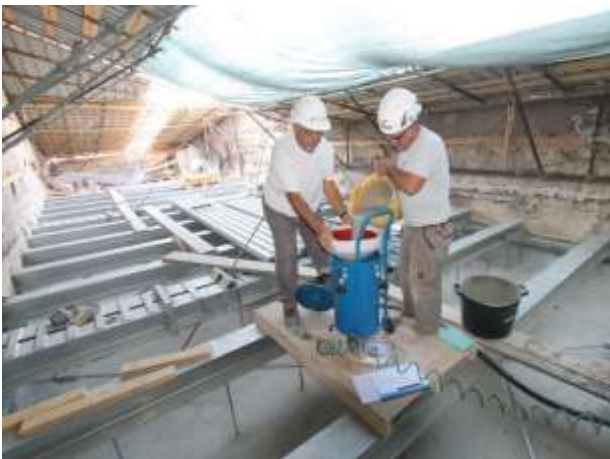
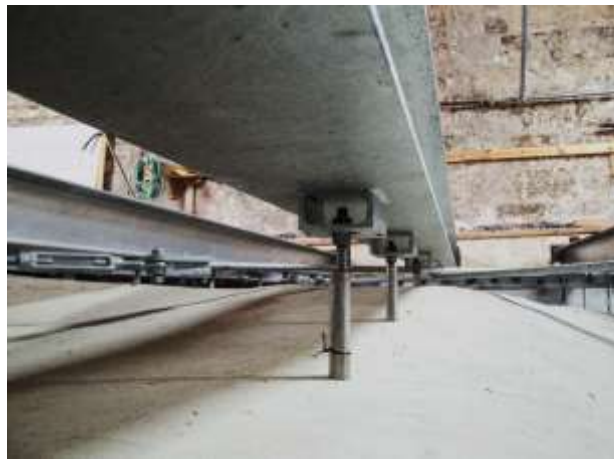
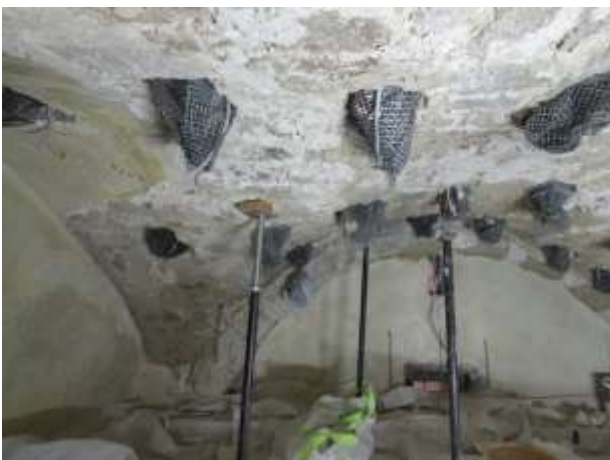
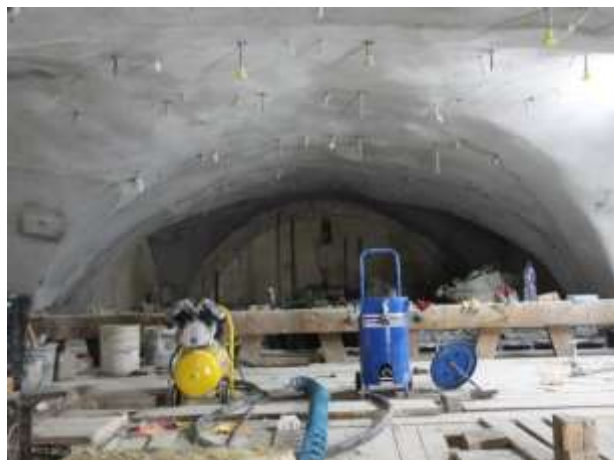
By the completion of consolidation of the Narthex vaults and the restoration of the internal stone facades and reaching a safe structural conditions, the contractor was able to remove the old wooden propping system that was supporting the damaged vaults since 1935 during the British mandate.

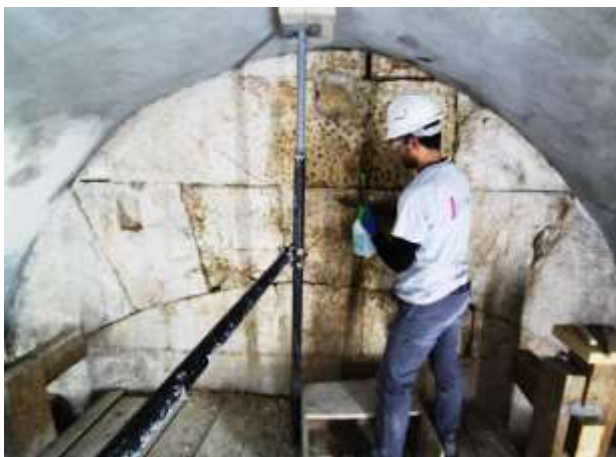
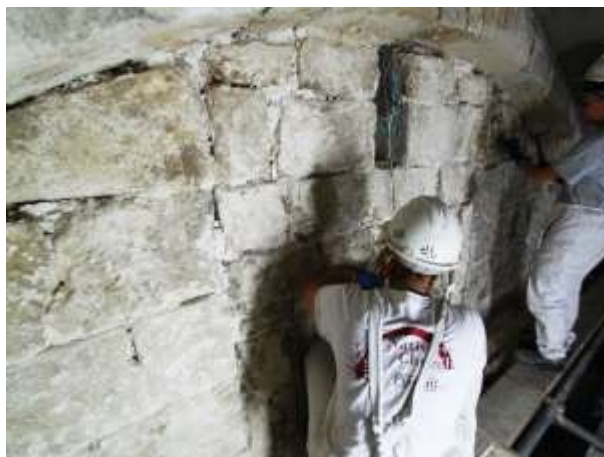
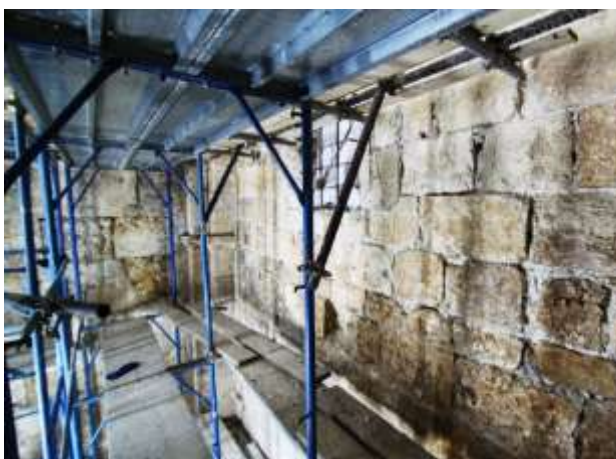
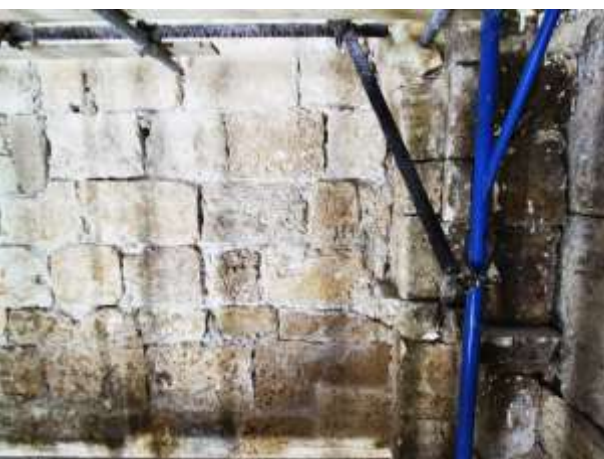
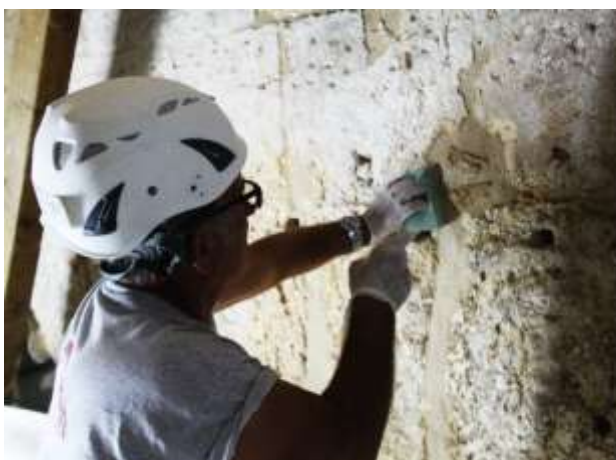
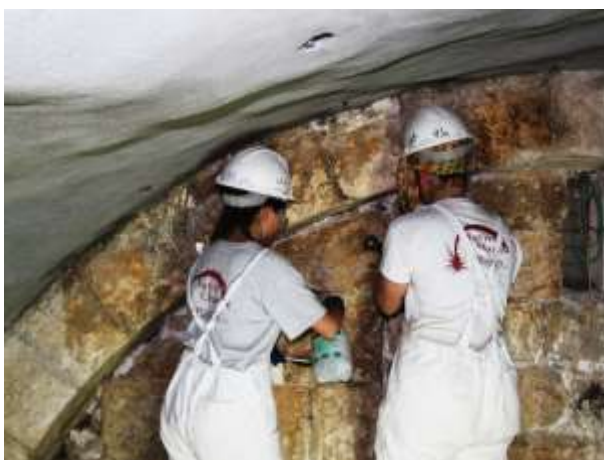
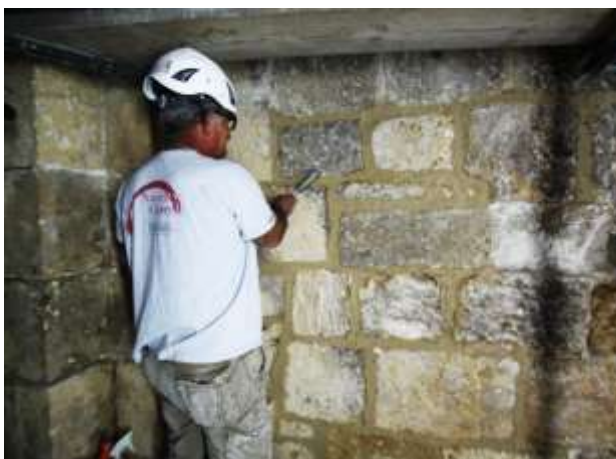
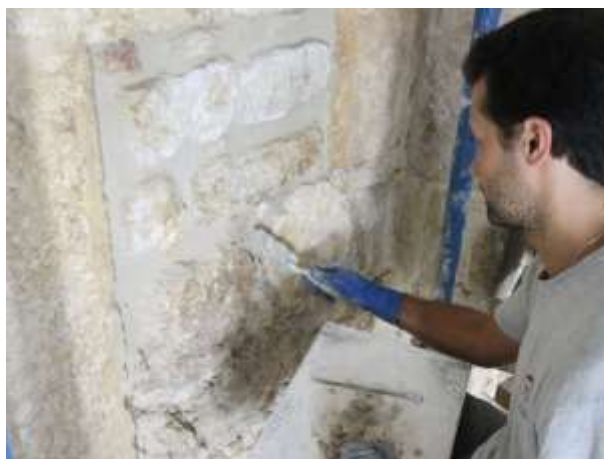
The Narthex area before and after the consolidation and restoration works

The restoration of the Narthex internal stone:

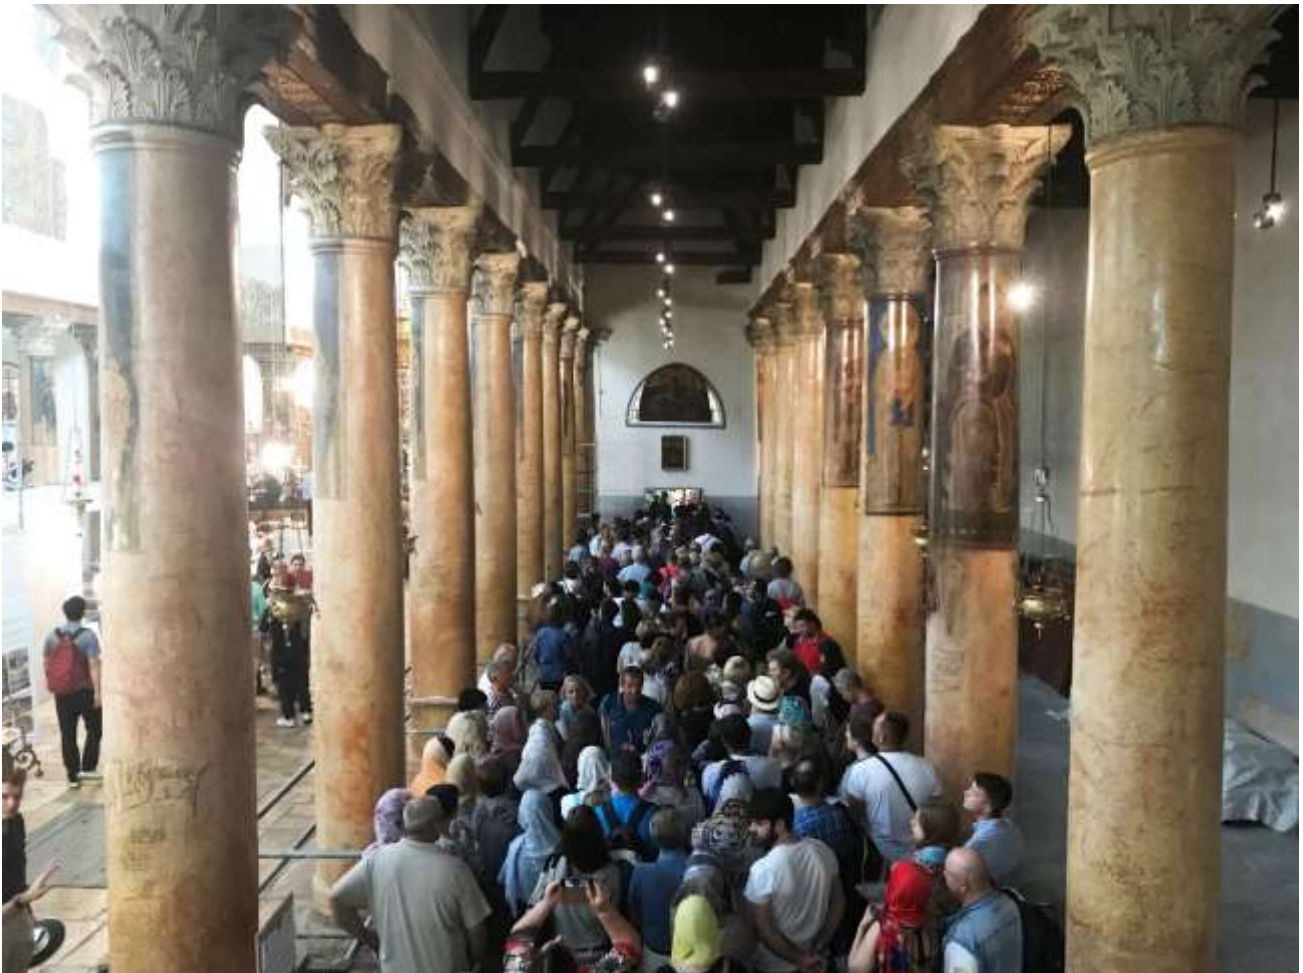
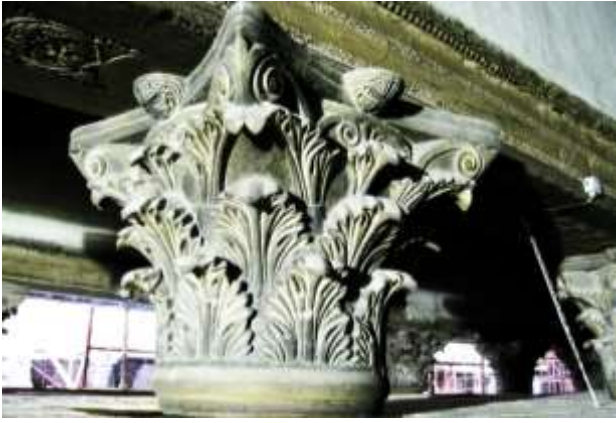
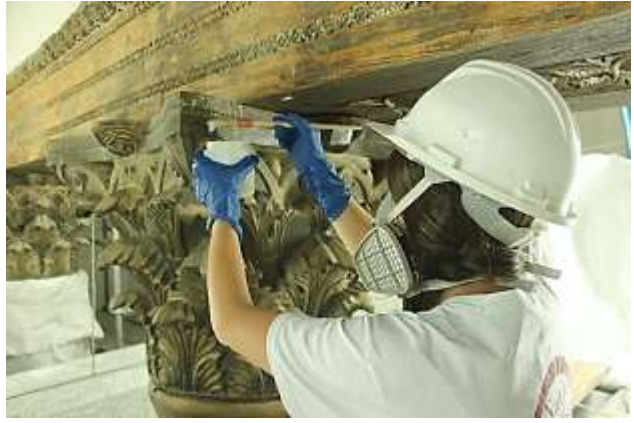
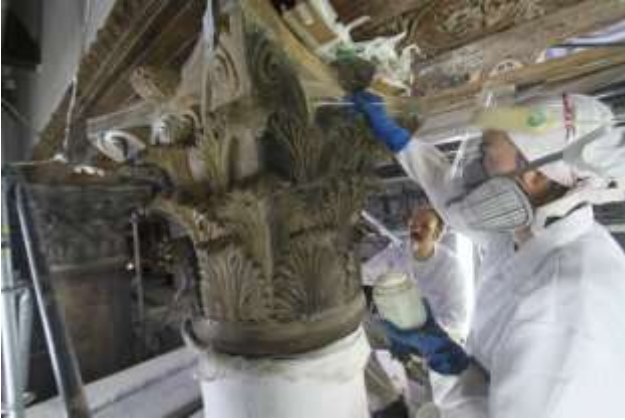
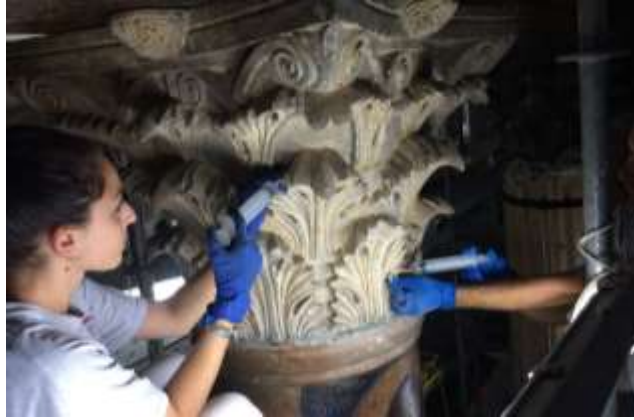
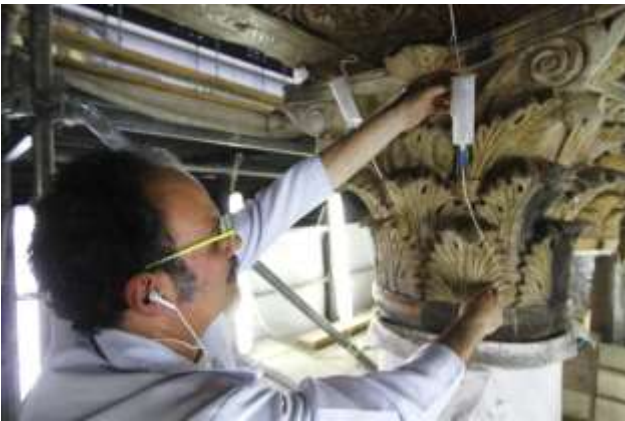
## 24 THE RESTORATION OF THE STONE COLUMNS:

The Presidential Committee has authorized the restoration of the Basilica 50 columns and 10 capitals (no column shaft or base). The restoration of 48 columns and the 10 capitals were completed. This achievement enabled the Church pilgrims and visitors to enjoy the beauty of the restored columns and their paints, graffiti and ancient inscriptions.

The restoration includes the cleaning and consolidation of the capitals, shaft and the bases, which consists the removing of the coherent and incoherent deposits, consolidation of the existing cracks and holes, and also the cleaning and retouching of the existing paintings.
